Inspection Photos

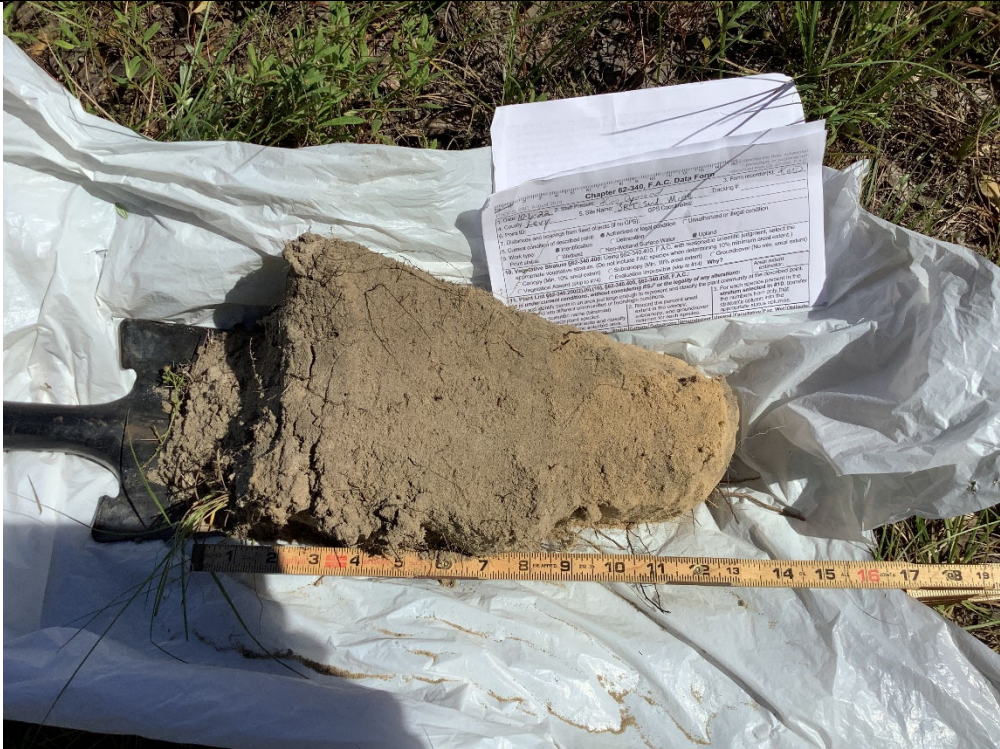
Image #:	1459
Photo Description:	Soil Profile
Photo Location:	N 29.40250° / W 82.58420°

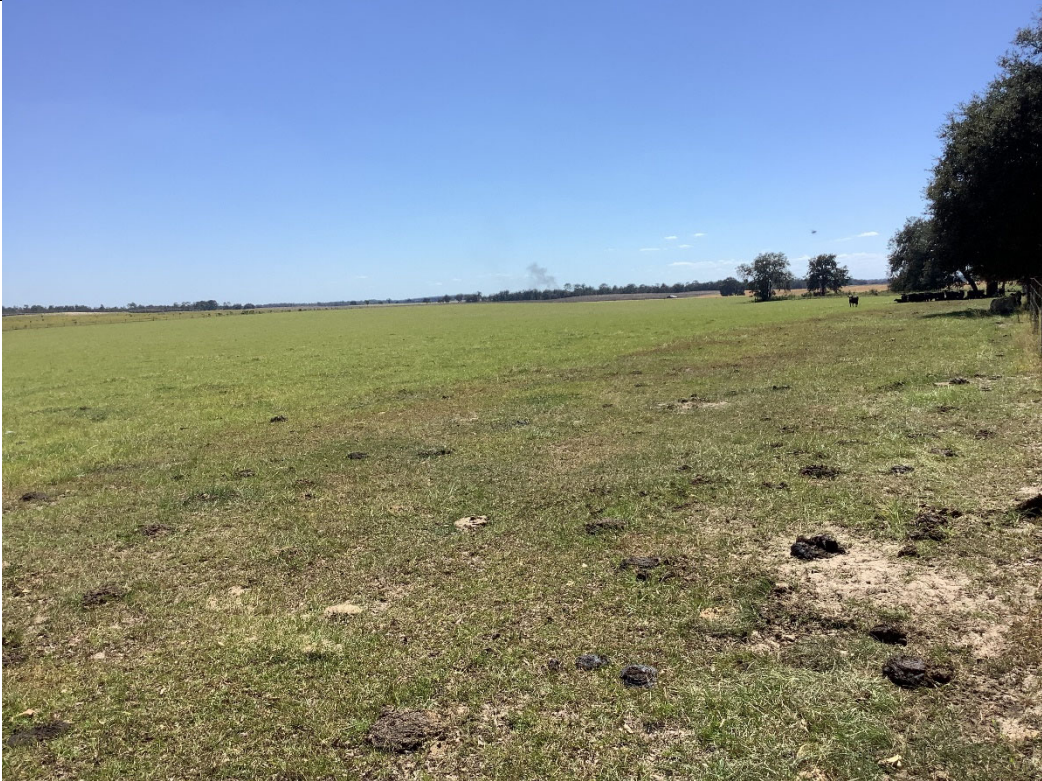
Image #:	1460
Photo Description:	Facing south
Photo Location:	N 29.40250° / W 82.58420°
