4.5 Sugar Creek

4.5.1 Introduction

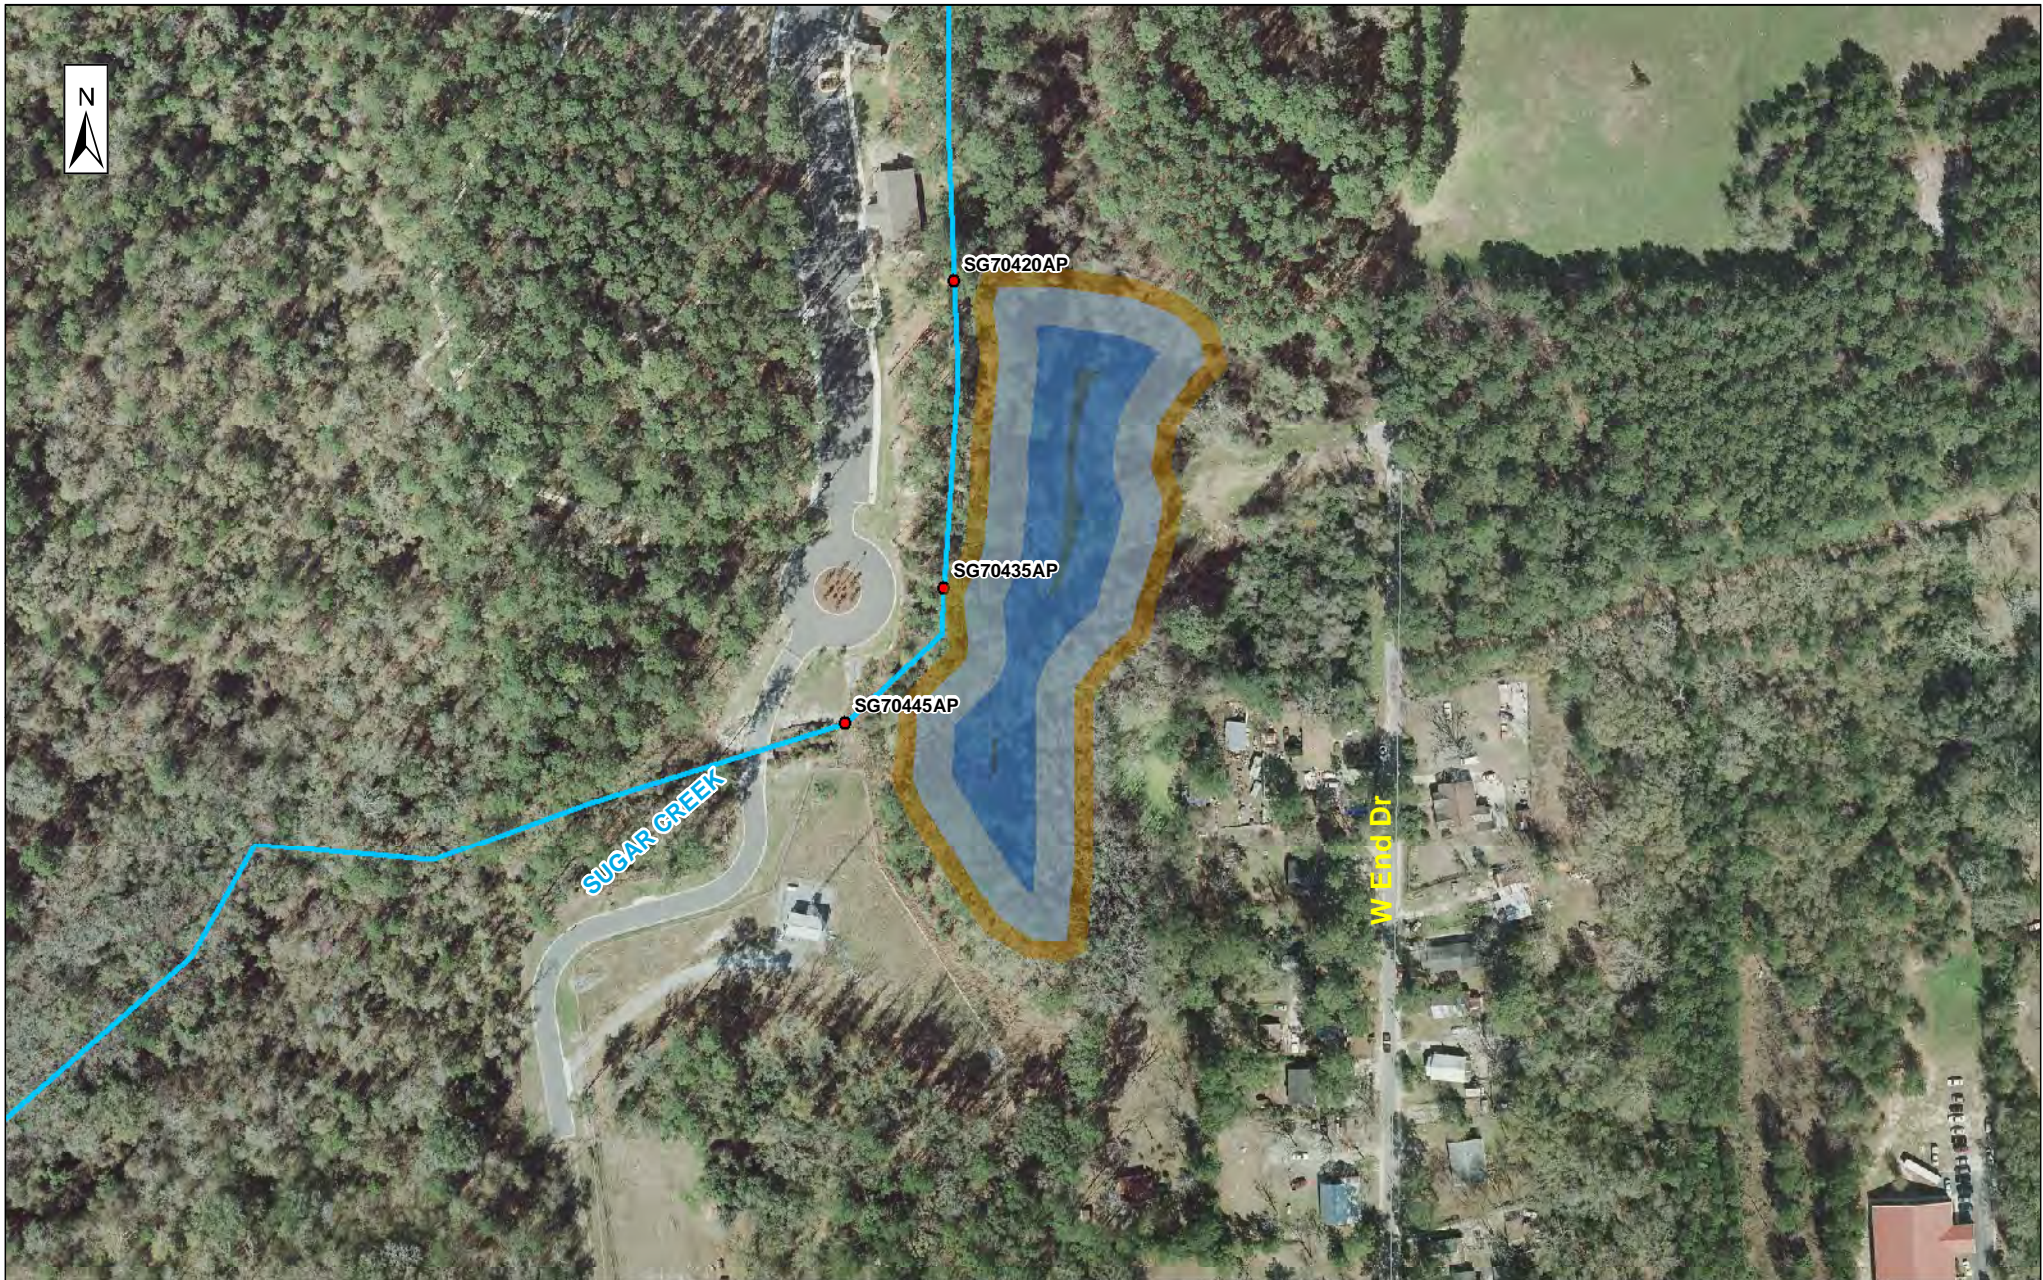
Figure 4.5.3
City of Valdosta, GA
Sugar Creek Sub-Basin
Alternative SG1
Regional Stormwater Facility near End Drive

This Alternative consists of constructing a 3.3-acre RSF near End Drive. The proposed RSF has a Permanent Pool Volume of 5.6 ac-ft and a Residence Time of more than 2 days. The tributary area to the facility is 267 acres. The implementation of this alternative will reduce some flooding in the neighboring structures along with reducing sediment loads.

The proposed RSF will treat 267 acres of untreated tributary area, and therefore may reduce sediment load. The land on which this facility is proposed is owned by the City. The location of the RSF is shown on **Figure 4.5.3**. **Table 4.5.5** shows the conceptual cost estimates for this alternative.

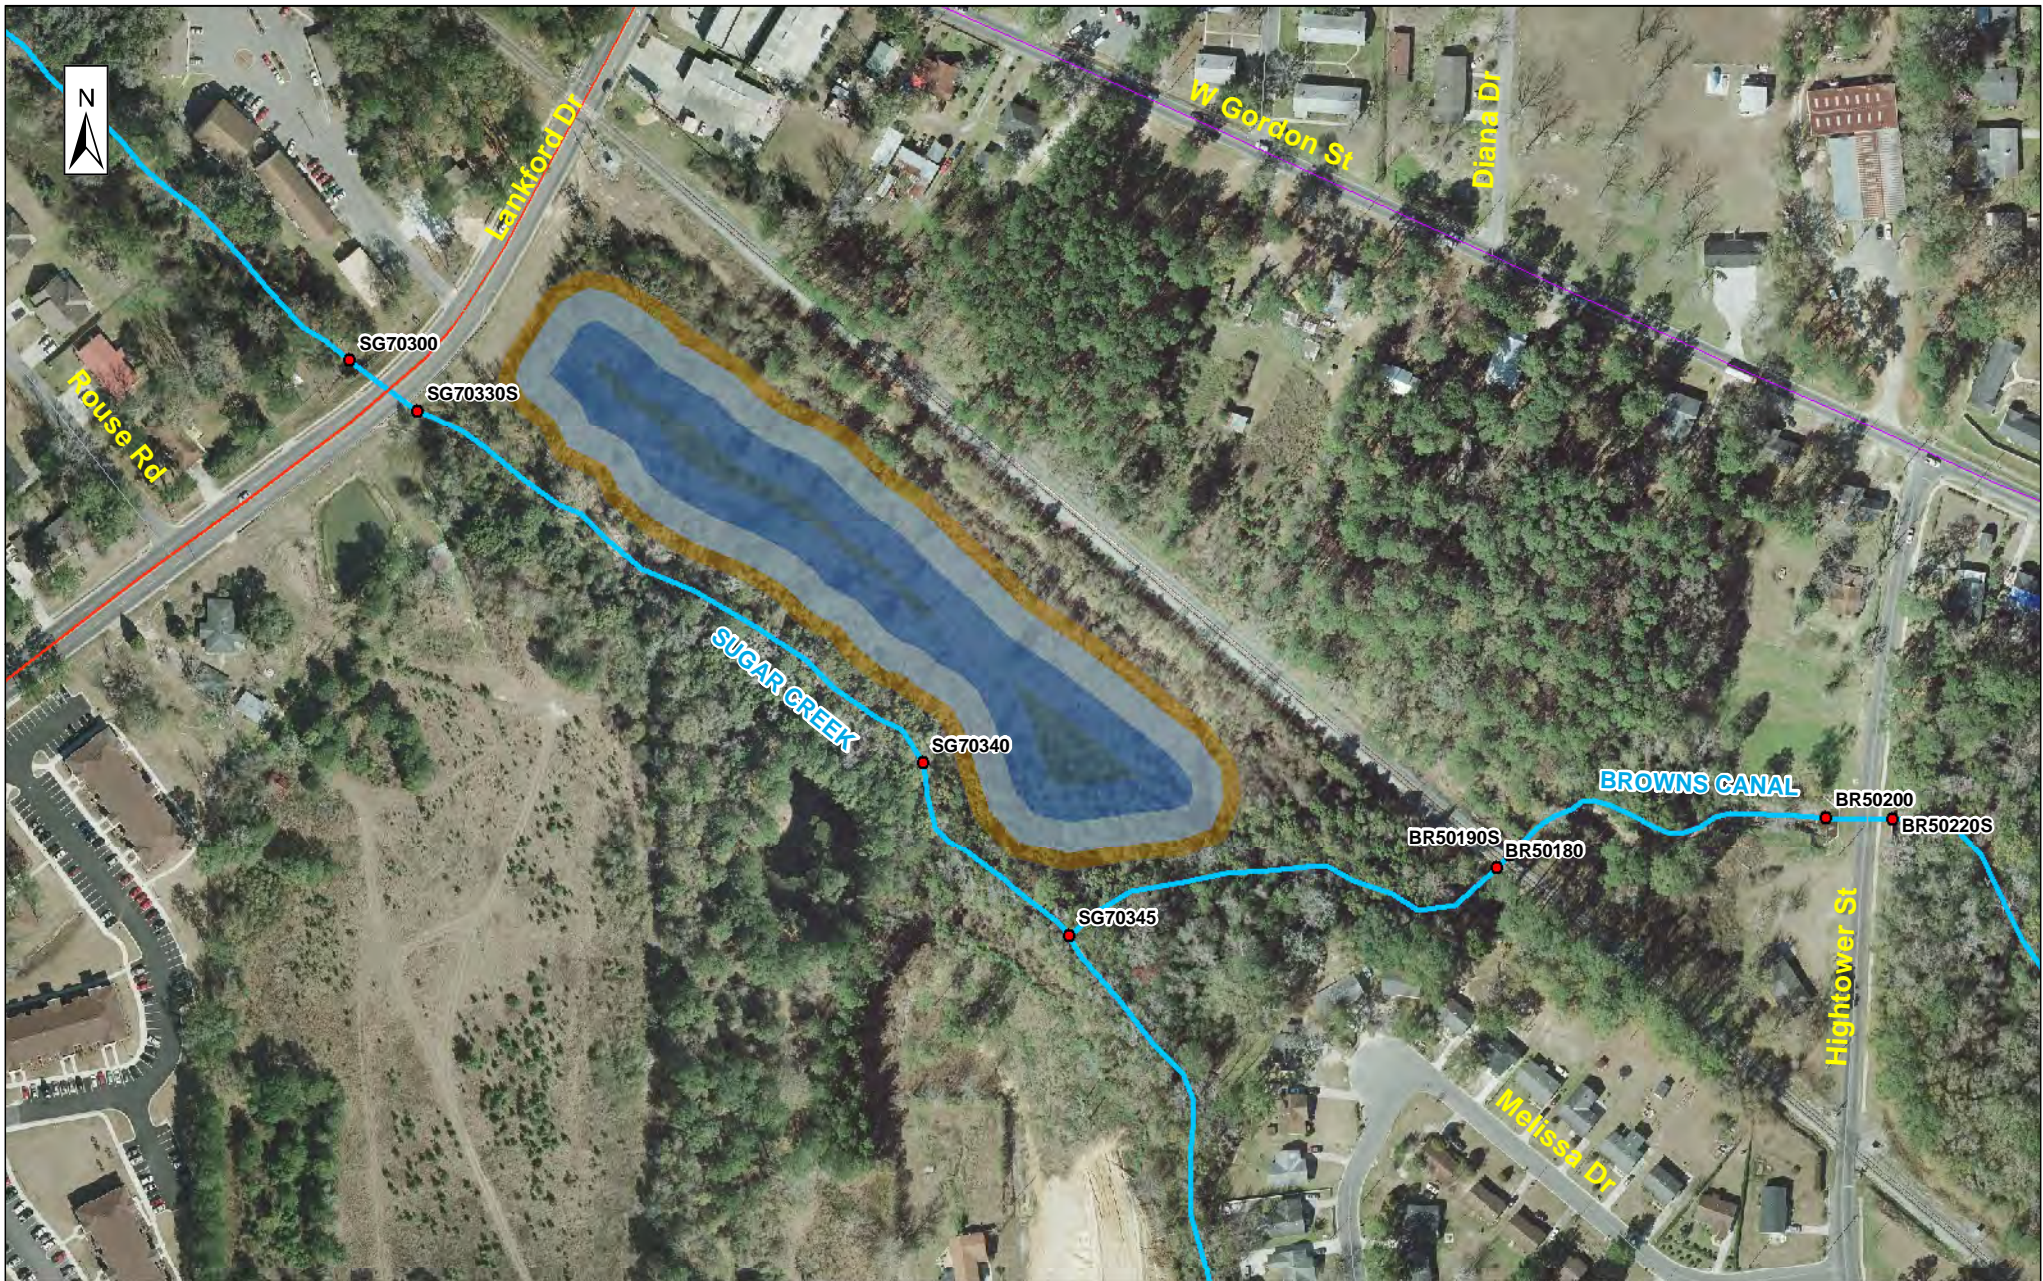
Figure 4.5.4
 City of Valdosta, GA
 Sugar Creek Sub-Basin
 Alternative SG2

This Alternative consists of constructing a 4.8-acre RSF upstream of Lankford Drive. The proposed RSF has a Permanent Pool Volume of 12.1 ac-ft and a Residence Time of 2.9 days. The tributary area to the facility is 1,421 acres. The implementation of this alternative will reduce some flooding in the neighboring structures along with reducing sediment loads.

The proposed RSF will treat 1,421 acres of untreated tributary area, and therefore will reduce sediment load. However, the land on which this facility is proposed is not owned by the City. The location of the RSF is shown on **Figure 4.5.4**. This location has a great potential for creation of a recreational area for citizens next to the RSF. **Table 4.5.6** shows the conceptual cost estimates for this alternative.

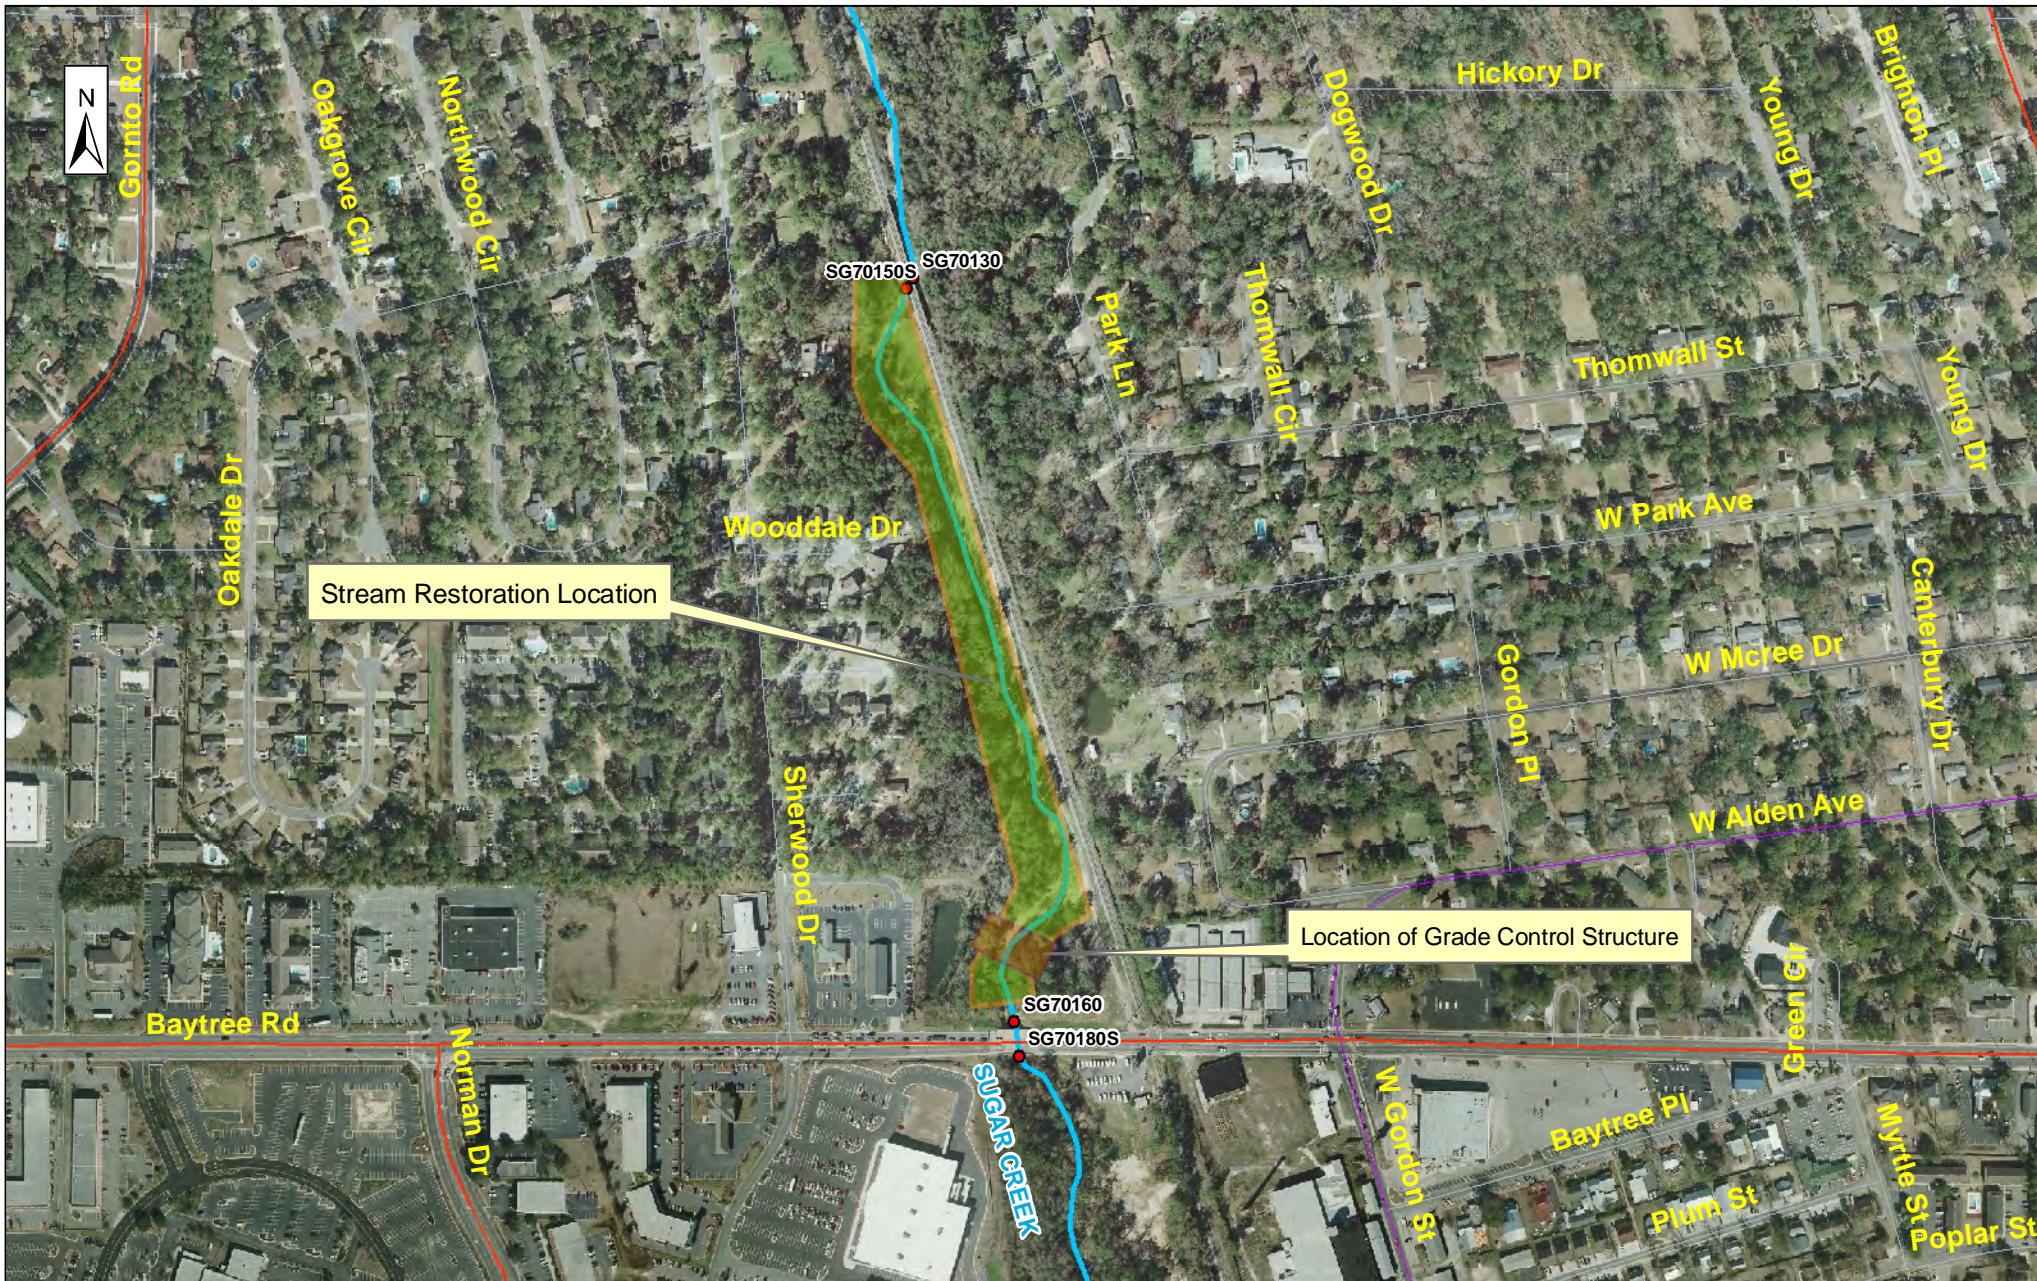
Figure 4.5.5
 City of Valdosta, GA
 Sugar Creek Sub-Basin
 Alternative SG3
 Sugar Creek Stream Restoration and a
 Grade Control Structure North of Baytree Rd

During the extensive field investigations along with the geomorphologic assessment of Sugar Creek, about 2,000 linear feet of creek north of Baytree Road were found to be in immediate need of attention and restoration. Widespread channel erosion and loss of trees was noticed. Some form of stream restoration/intervention is proposed for this section of Sugar Creek. Spot intervention at specific strategic locations along this section of Sugar Creek can also prove to be beneficial.

Along with the stream restoration structures, a grade control structure just downstream of Baytree Road Bridge is also proposed. This will act as an energy dissipater and also help in reducing the velocities in the stream. The kind of stream restoration structure to be implemented in this stream is subject to more detailed analysis of the stream. The location of this project is shown on **Figure 4.5.5**. **Table 4.5.7** shows the conceptual costs estimates for this alternative.
