The Chemours Company FC LLC  
Titanium Technologies Florida Plant  
5222 Treat Road, PO Box 753  
Starke FL 32091

RE: The Chemours Company FC LLC  
Trail Ridge South Release  
Incident No. 2024-0997

The following provides additional information pertaining to the discharge of water from the Trail Ridge South facility on January 31, 2024.

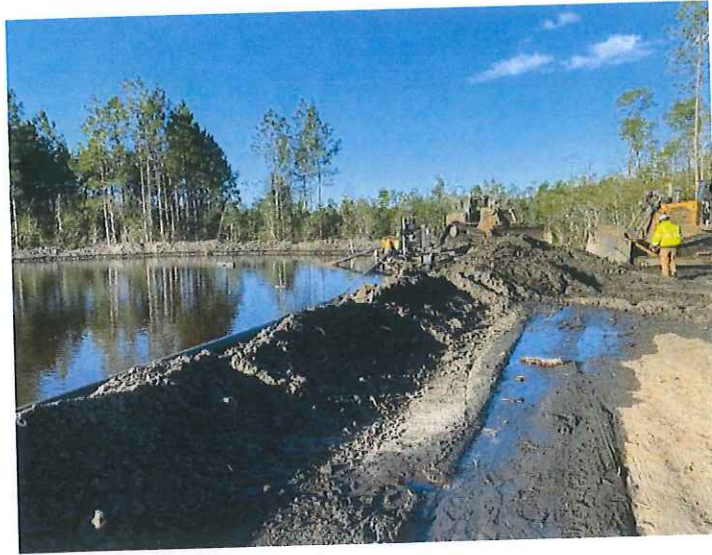
As discussed with our original notification, cells are in various phases of mining activity (clearing, mining, tailing and reclamation). Reclamation is ongoing in the northwest corner of the mining boundary. A portion of the reclamation cell remains bermed (northern perimeter and portion of western perimeter). Topsoil was being returned in the southern portion of the reclamation cell. At 6:20 am, operators noticed water on the topsoiled area and also water flowing over the northwest berm. Operators immediately constructed a berm to contain the water from the topsoiled area and built up the northwest corner of the remaining berm. Supervision was notified and the operations were shut down. Review of the area for source of water indicated a "washout" by the active tailings line which caused water to flow back toward the reclamation cell. From the topsoiled area, water left the site at an historic fire break and water from the northwest corner of the reclamation cell entered the adjacent offsite wetland. The water did not contain humate and there was not any breach of the reclamation cell structure. There was no deposition of sediment in the wetland.

**Northwest corner Reclamation cell  
(January 31, 2024)**

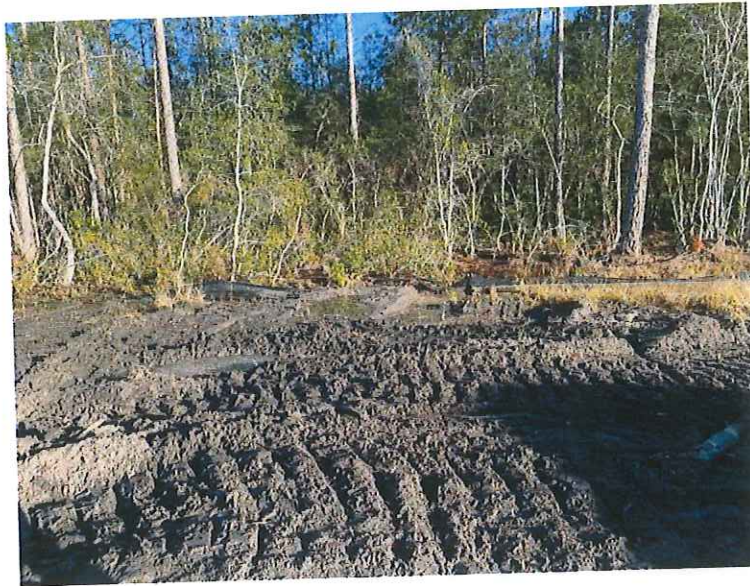
Area 1 is located along the northern and portion of the western boundary of the reclamation cell. This is a mixed forested wetland system. There was little to no flow within the area around the reclamation cell at the time of review. Water had accumulated within and around the hummocks in the wetland. Water depths were approximately 3-6 inches throughout the area reviewed. Observations within the wetland showed some areas of "cloudy" water and areas of clear water.

**Northwest Corner Reclamation cell – Where water entered wetland  
(January 31, 2024)**

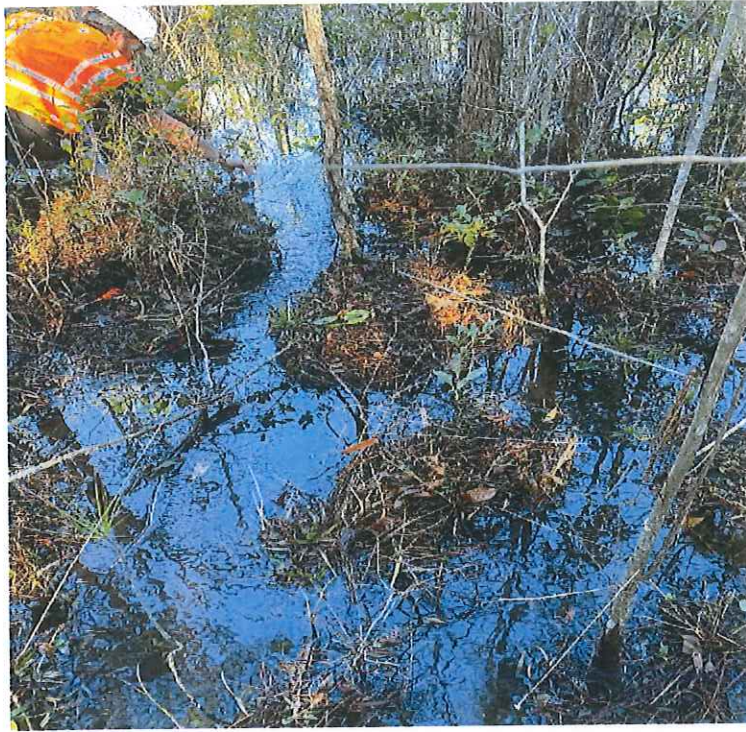
1 include Sample 2, 3, 4 and 5. Sample 1 had no flow at the time of sampling and the nephelometric turbidity unit (NTU) was 57. The highest NTU was 77 at Sample location 3.

Representation of Wetland  
Sample 5 (January 31, 2024)

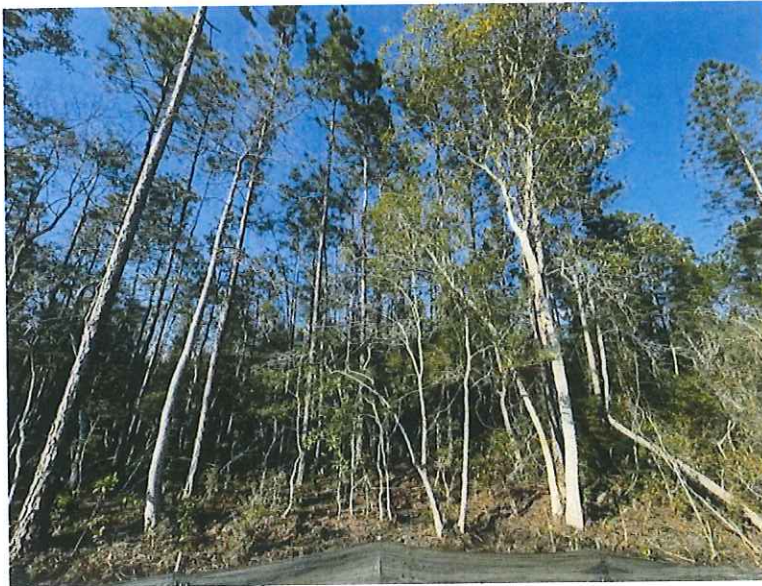
Water samples were taken at the Sample 1 location in the PM on January 31 and on February 1, though there was no flow. The location dried so no additional samples were taken. Sample locations 2, 3, 4, 5 were not sampled after the initial sample as the majority of the water had soaked into the ground and there was either no water or very little ponded water.

Northwest corner Reclamation Cell  
Representation of wetland (February 1, 2024)

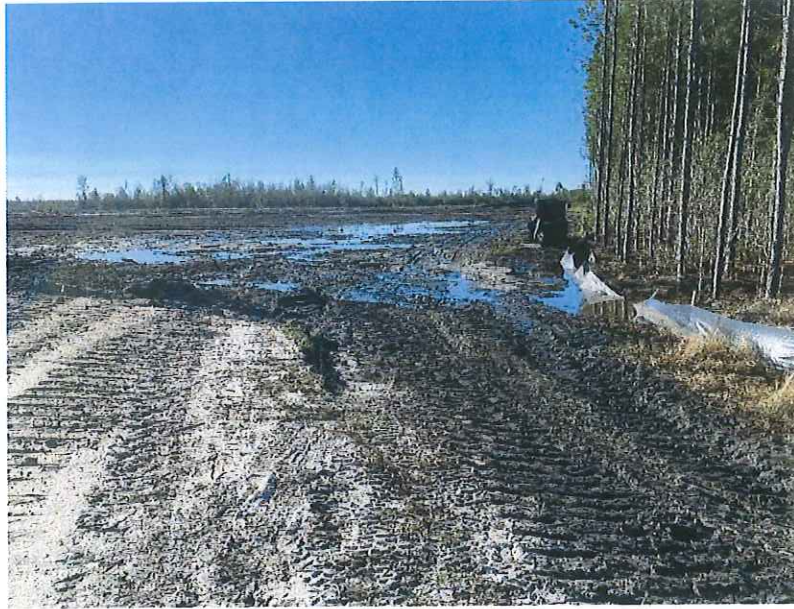
The water that flowed over the topsoil returned area exited the site within a fire break that borders the wetland. Three samples were taken at this point (Samples 6, 7 and 8). No additional samples were taken as the water was evaporating and soaking into the ground.

Area 2  
Water on Topsoil return area (January 31, 2024)

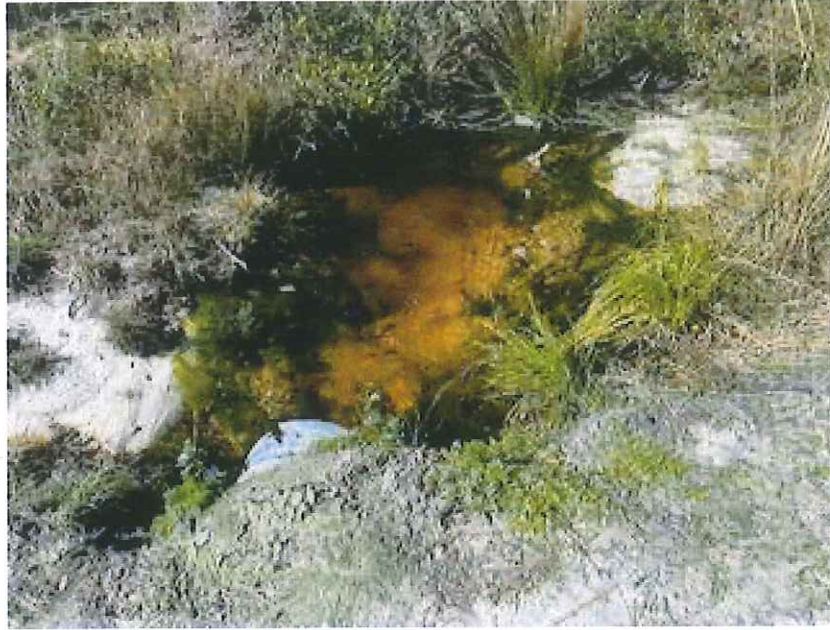
Samples continued to be taken two times per day from January 31, 2024 – February 4, 2024 at the perimeter locations; Sample 9 and 10. One sample was taken February 5, 2024.

Perimeter Sample Location 9 (January 31, 2024)

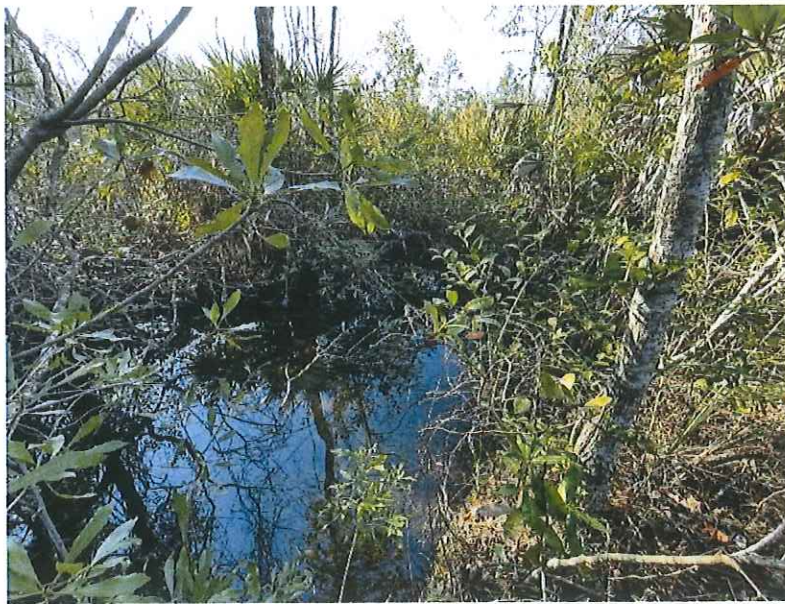
The perimeter sampling locations 9 and 10 were sampled through the morning of February 5, 2024. Turbidity within location 10 experienced an increase to 13.4 NTU on February 1, 2024 during the pm sampling event. This station increased to a 15 NTU on the morning of February 2, 2024 and decreased on subsequent sampling events. As indicated previously, there was no sediment deposition within the offsite wetlands.

Perimeter Sample Location 10 (January 31, 2024)

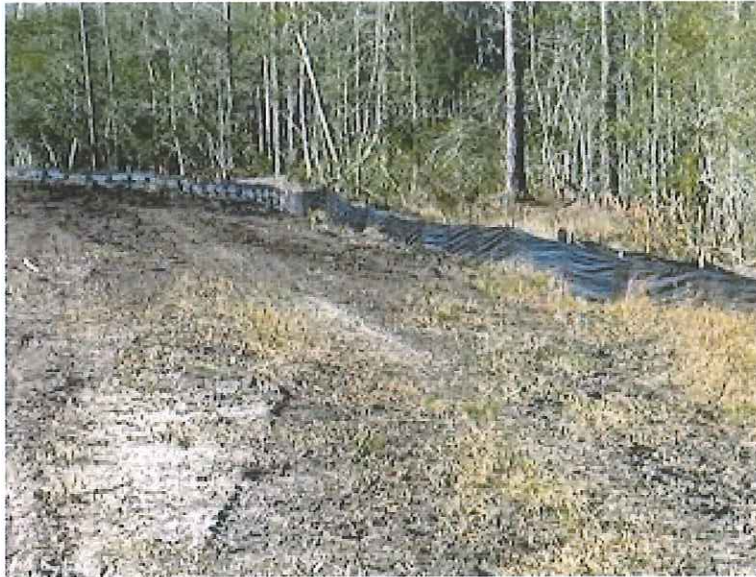
Silt Fence Repaired (January 31, 2024)

- Supervision and Environmental notified
- Rain pump in cell started to reduce water levels
- Environmental Assessment of release area
- Silt fence repair
