RE: Response to USACE Comments and Revised Adaptive Management Plan to address Trespassing, Buffer Replanting, and Invasive Species Management; Cherry Creek Mitigation Bank, Lowndes County, Georgia.
USACE File No: SAS-1999-10930

Figure 1
 Existing Conditions Map

RE: Supplemental Planting and Trespass Plan in response to Year 6 Credit Release Letter for Cherry Creek Mitigation Bank, Lowndes County, Georgia.
USACE File No: SAS-1999-10930

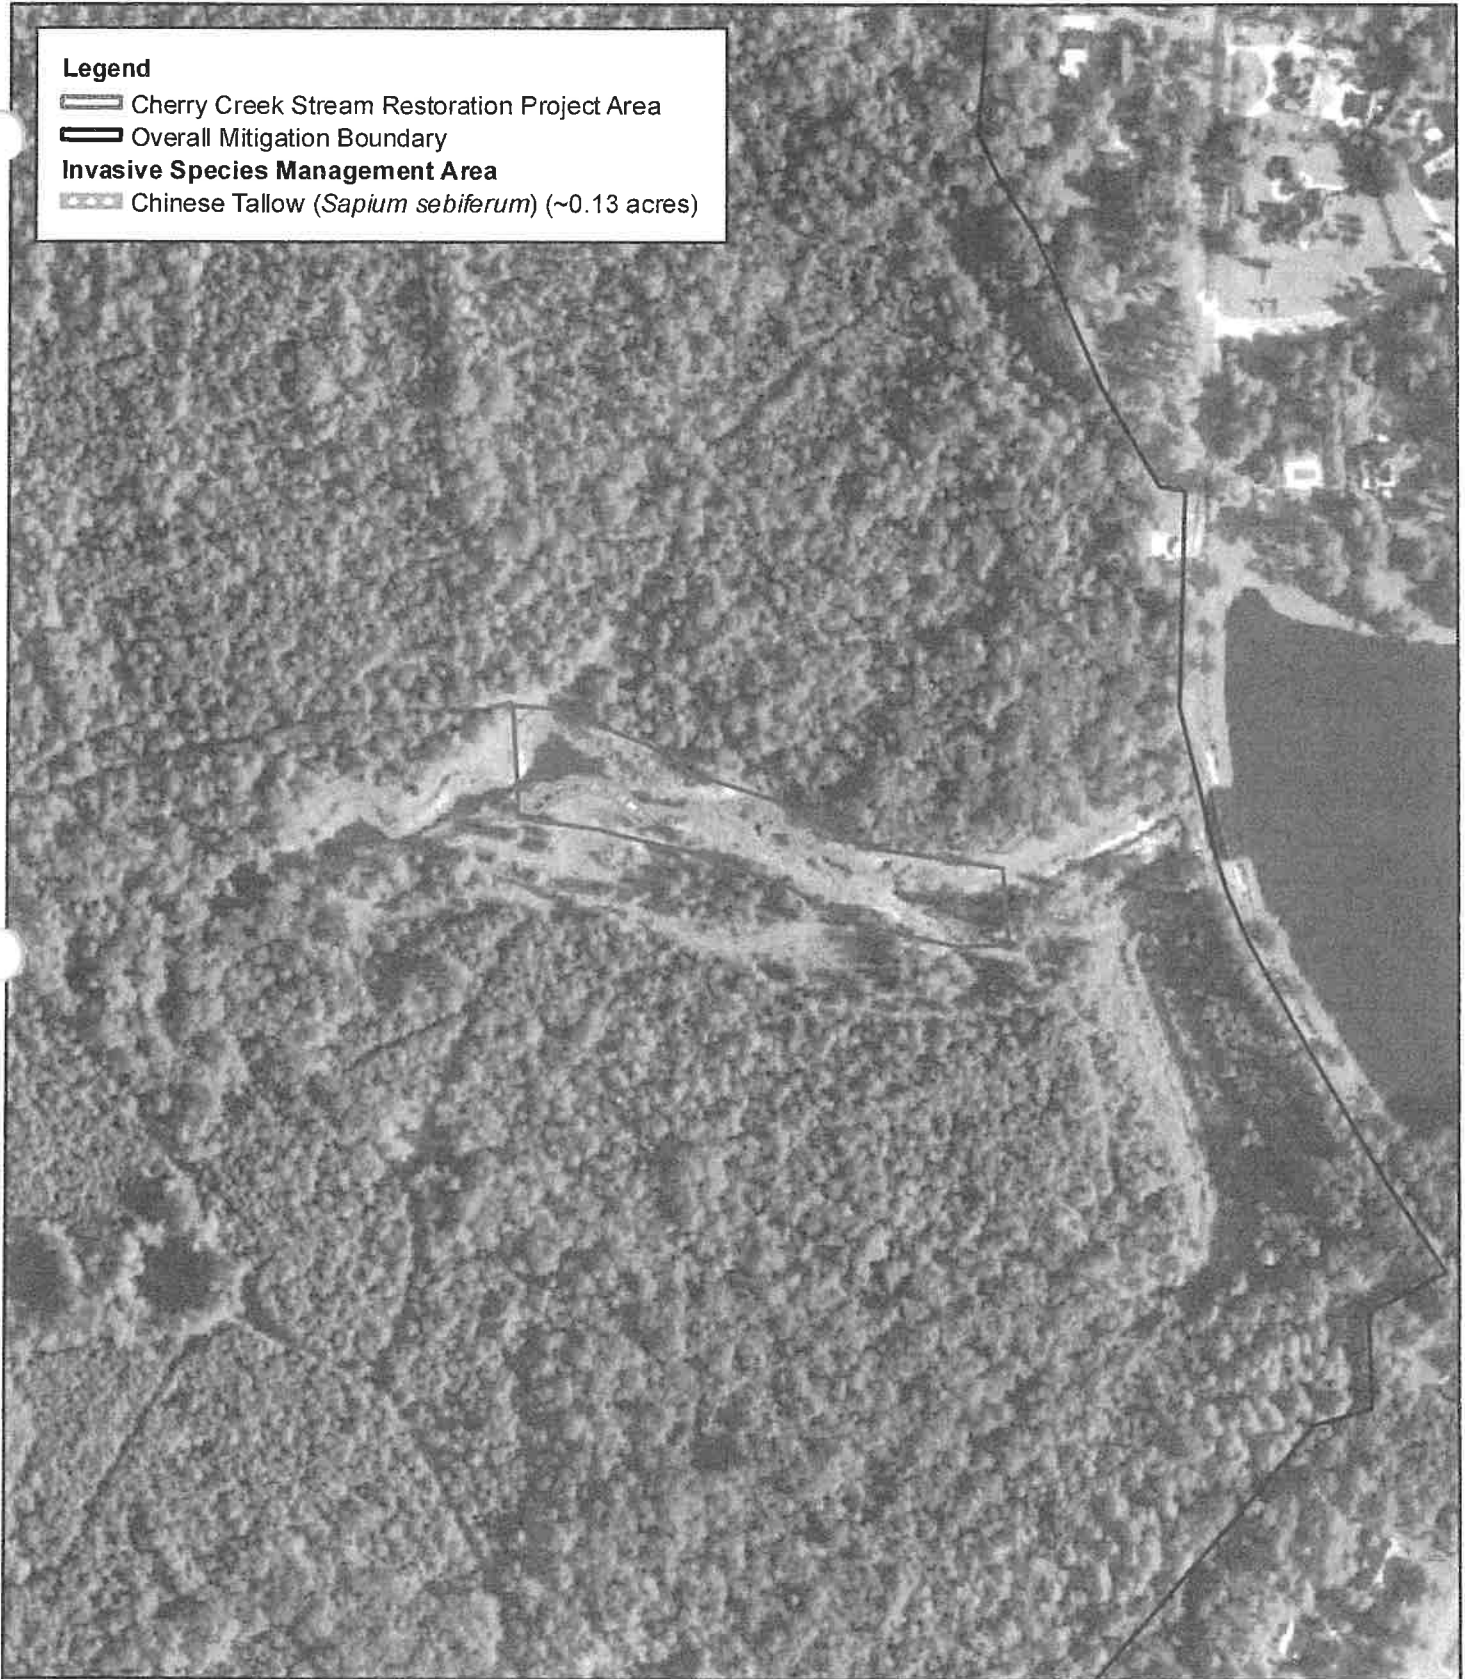
Figure 4
Invasive Species
Management Map

- 1) Figure 4 identifies the invasive species management area to be treated (approximately 0.13 acres).

Chinese Tallow (*Sapium sebiferum*) (~0.13 acres)

- 2) Any observed Chinese tallow trees in the identified management area will be controlled using a basal spray treatment (bottom 2' of trunk) of Trycera + horticultural oil at a 20/80 mixture ratio.
- 3) Existing Chinese tallow at the bank is targeted to be treated at the earliest opportunity between the months of July-March when appropriate conditions exist, primarily when floodwaters from Withlacoochee River have receded. It has been shown that Chinese tallow is best treated between the months of July-March with the basal spray treatment method.
- 4) The frequency and timing of existing and future invasive species management at the bank will include the following:

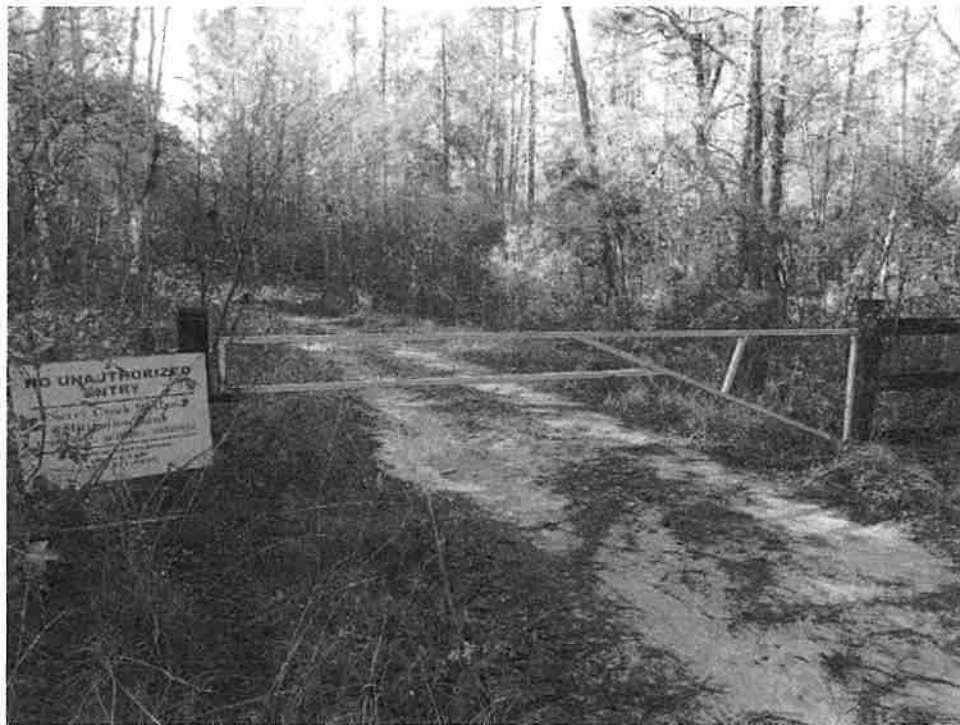
Photo 1: View of the metal gate controlling access to the northern portion of the site. A new lock and signage will be installed at this gate.

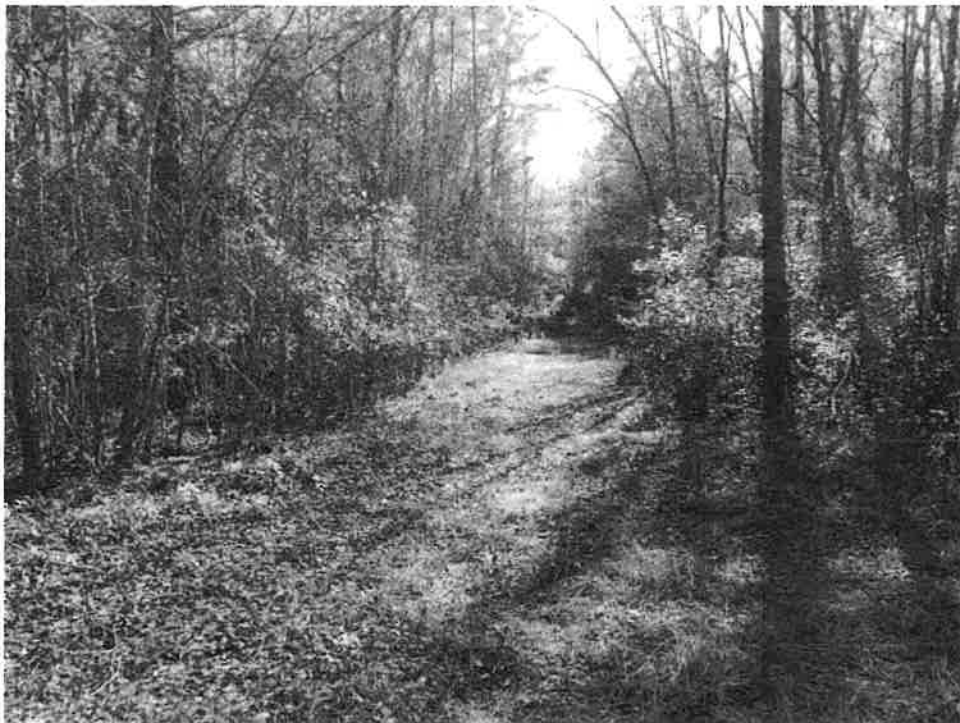
Photo 2: View of the woods road located on the northeastern portion of the site, just below the northern gate in Photo 1. A cable across this Road and signage will be installed.

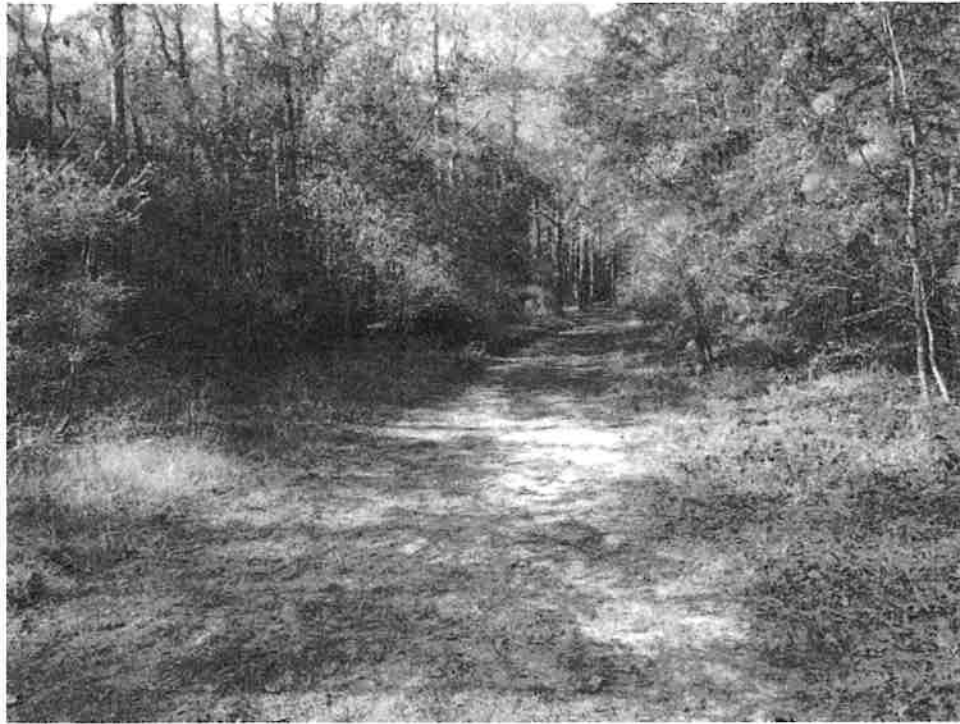
Photo 3: View of the woods road located on the northwestern portion of the site. A metal gate across this road and signage will be installed.

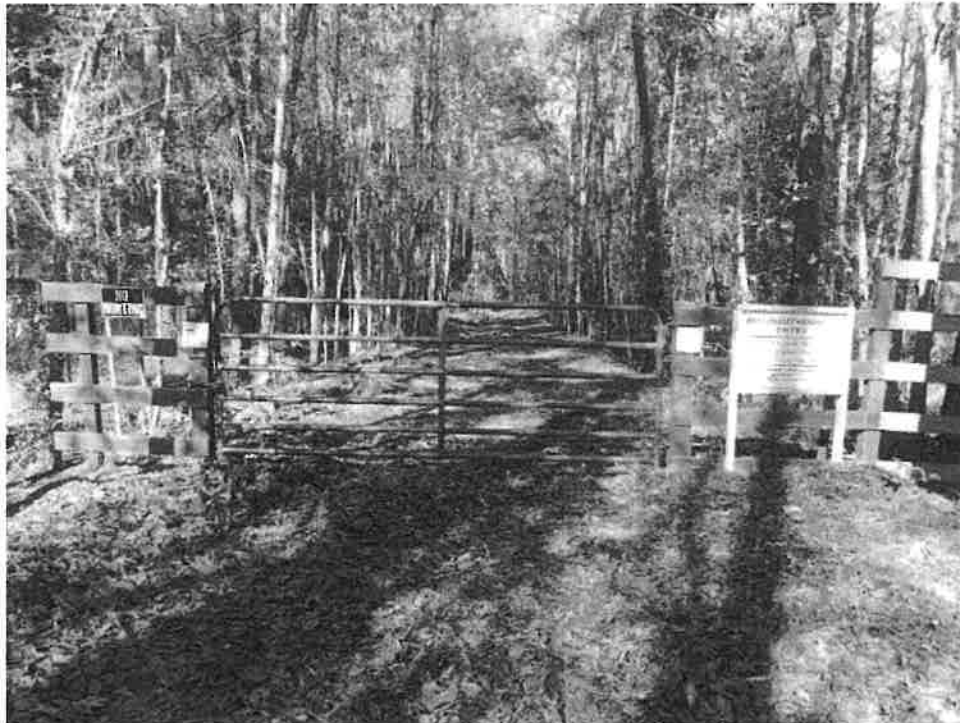
Photo 4: View of the metal gate controlling access to the southeastern portion of the site. A new lock and signage will be installed at this gate.

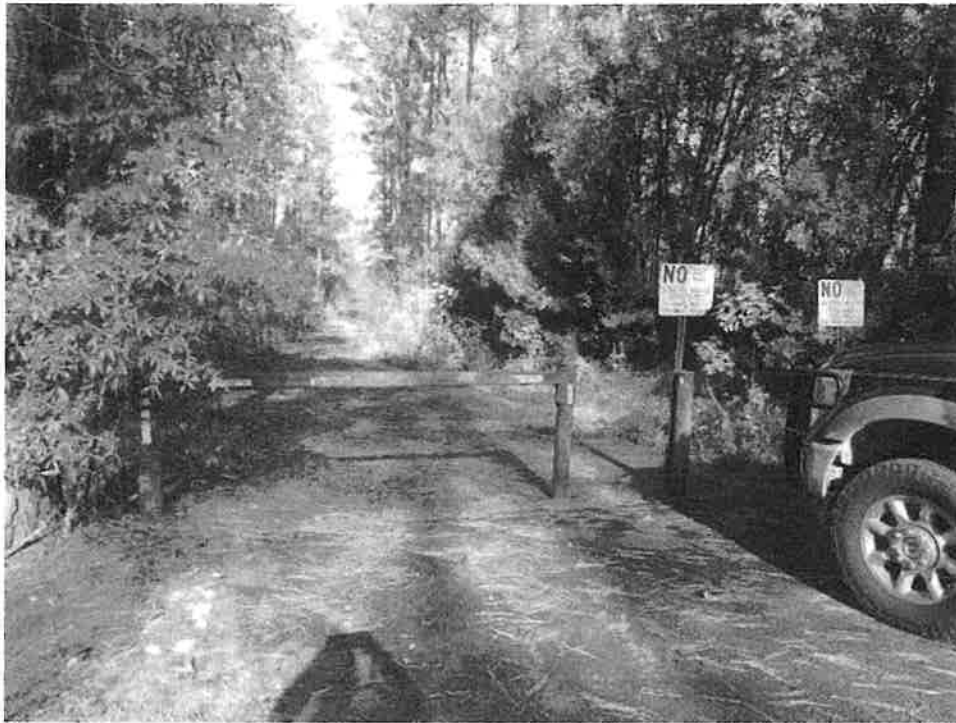
Photo 5: View of the metal gate controlling access to the dam access road, located on the southeastern corner of the site. A cable will be added to the right side of this entrance to further prevent access. Additional signage will be placed at this location.

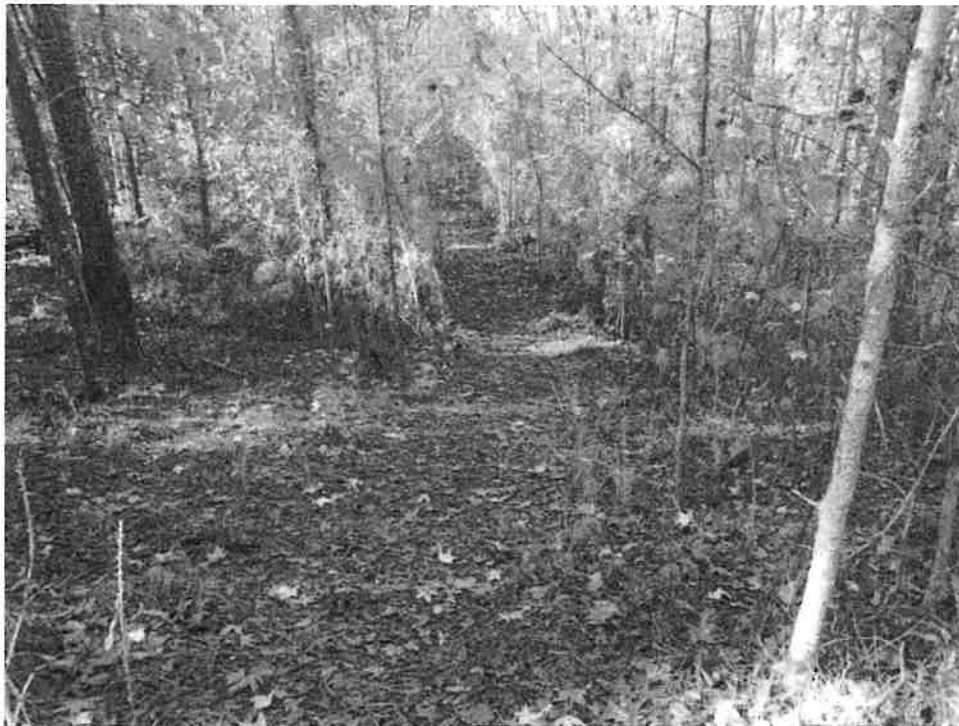
Photo 6: View of an ATV trail located just west of the dam access road. A cable across the trail and signage will be installed.

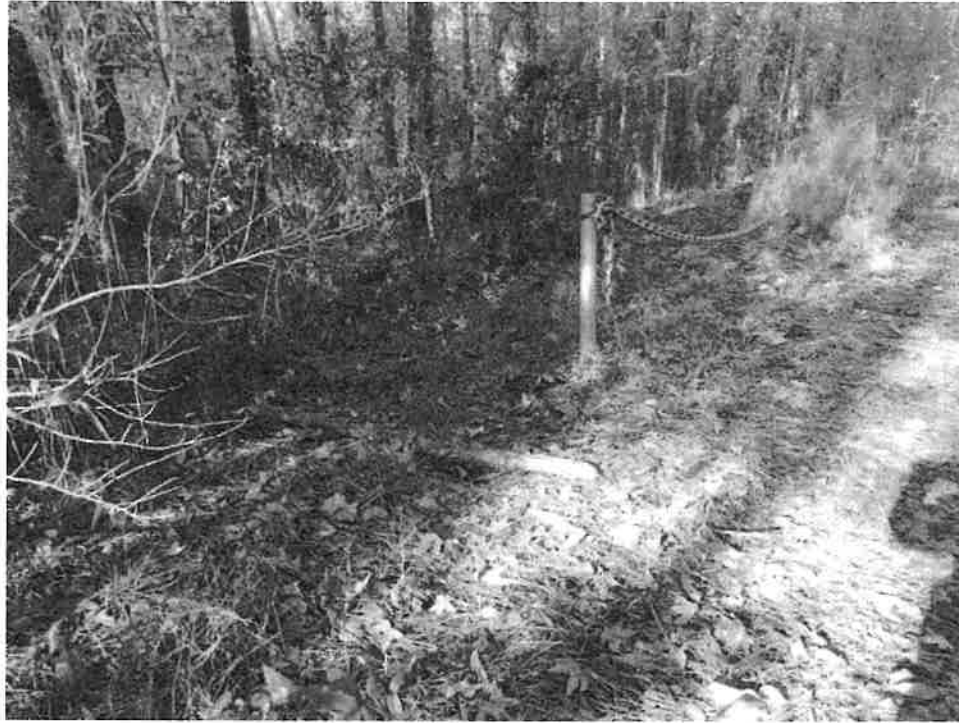
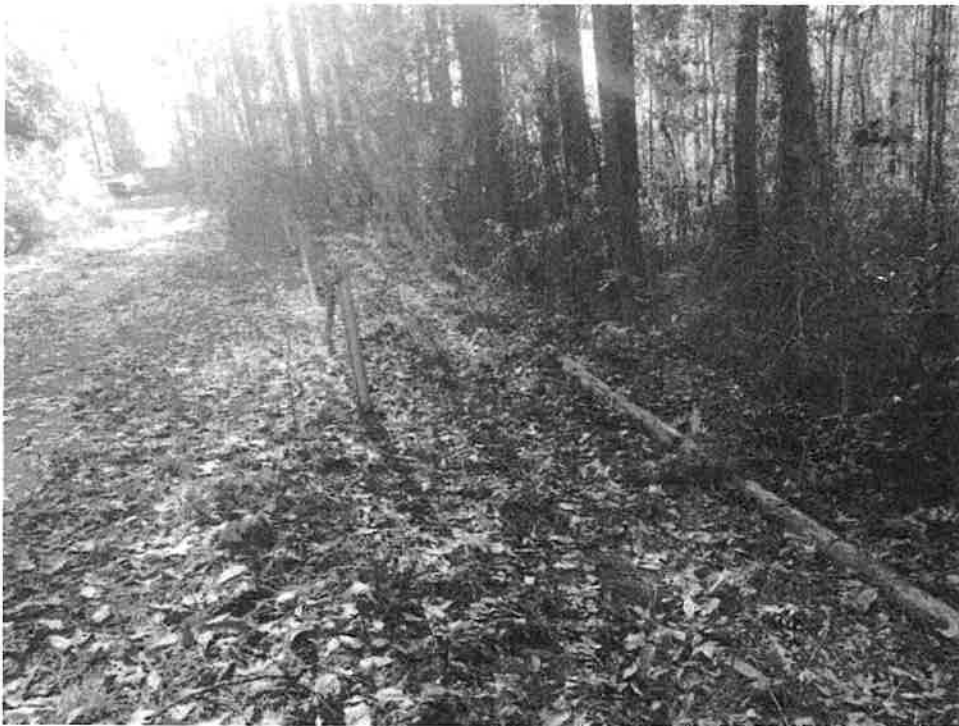
Photos 7 & 8: View of ATV access around both ends of the chain fence present along the southwest side of the dam access road, adjacent to the ATV trail shown in Photo 6. An additional section of fence will be installed to connect the fence along the entire length of the road. Additional signage will be placed in this location.

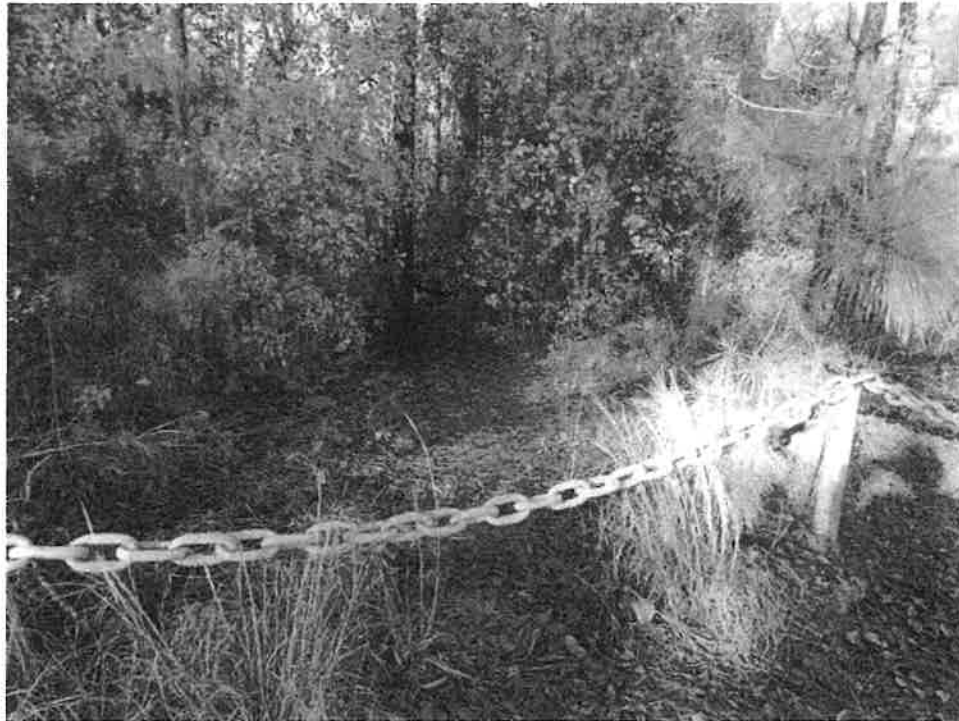
Photo 9: View of an area just south of the dam spillway along the dam access road that is being accessed on foot by individuals to fish along Cherry Creek. Additional signage will be added at this location.

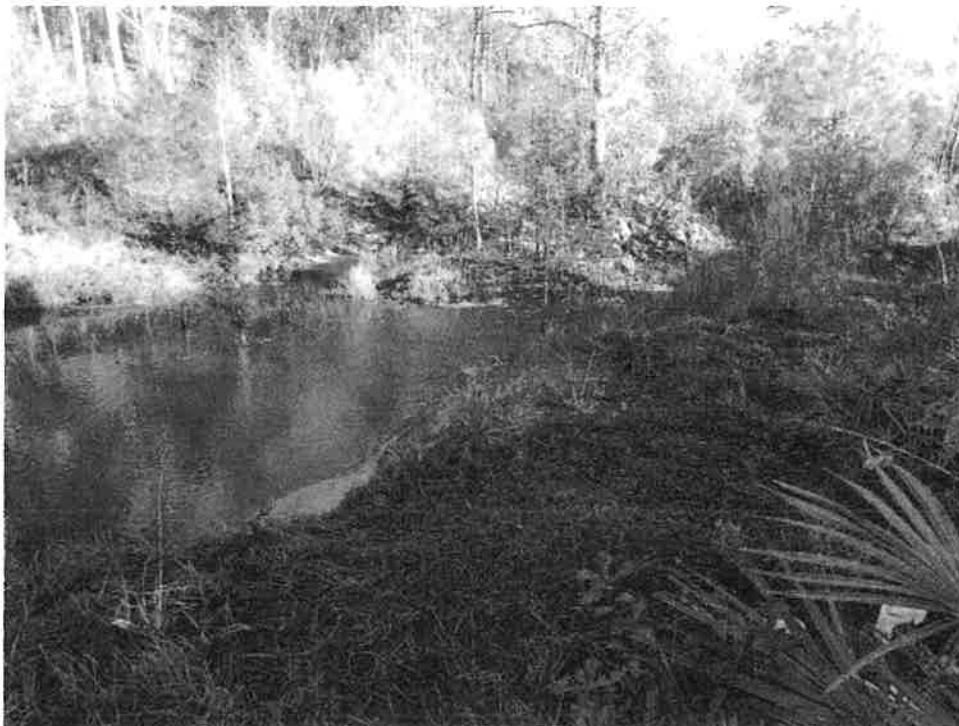
Photo 10: View of an area along Cherry Creek where individuals are regularly fishing. This area is accessed by the trail shown in Photo 9.

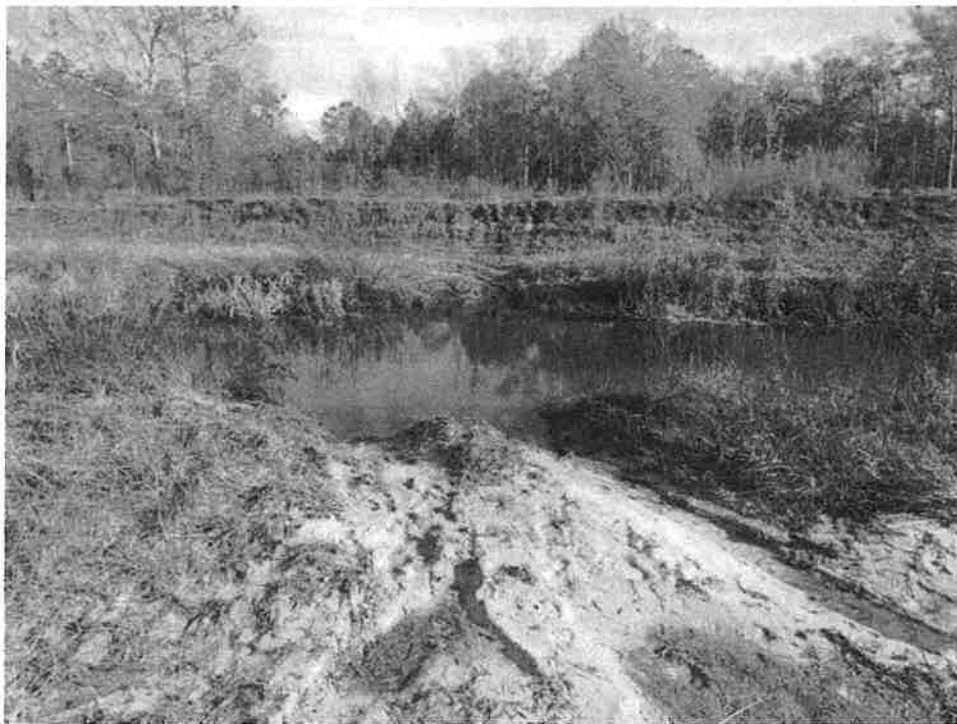
Photo 11: View of an unauthorized crossing on Cherry Creek. This crossing was created by off-road vehicles and ATV's trespassing on the site.

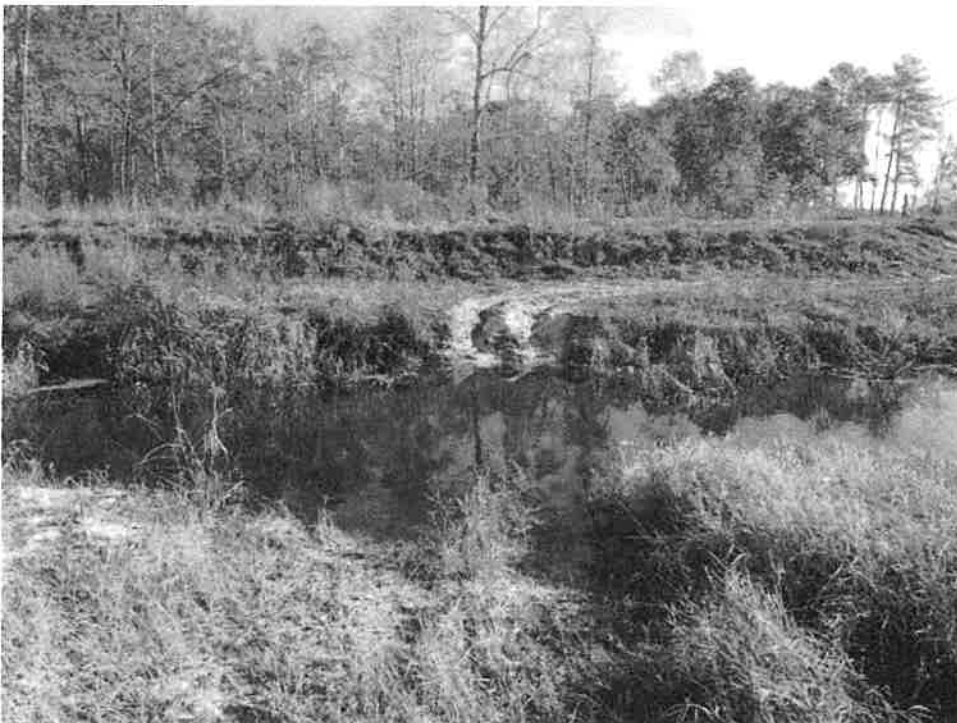
Photo 12: View of an unauthorized crossing on Cherry Creek. This crossing was created by off-road vehicles and ATV's trespassing on the site.

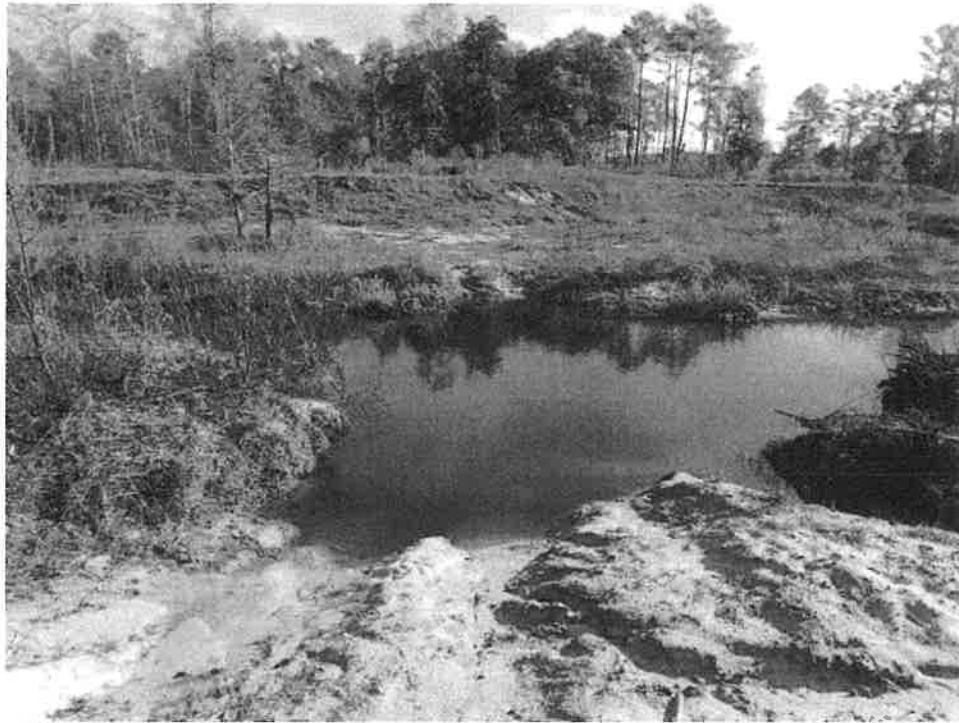
Photo 13: View of an unauthorized crossing on Cherry Creek. This crossing was created by off-road vehicles and ATV's trespassing on the site.

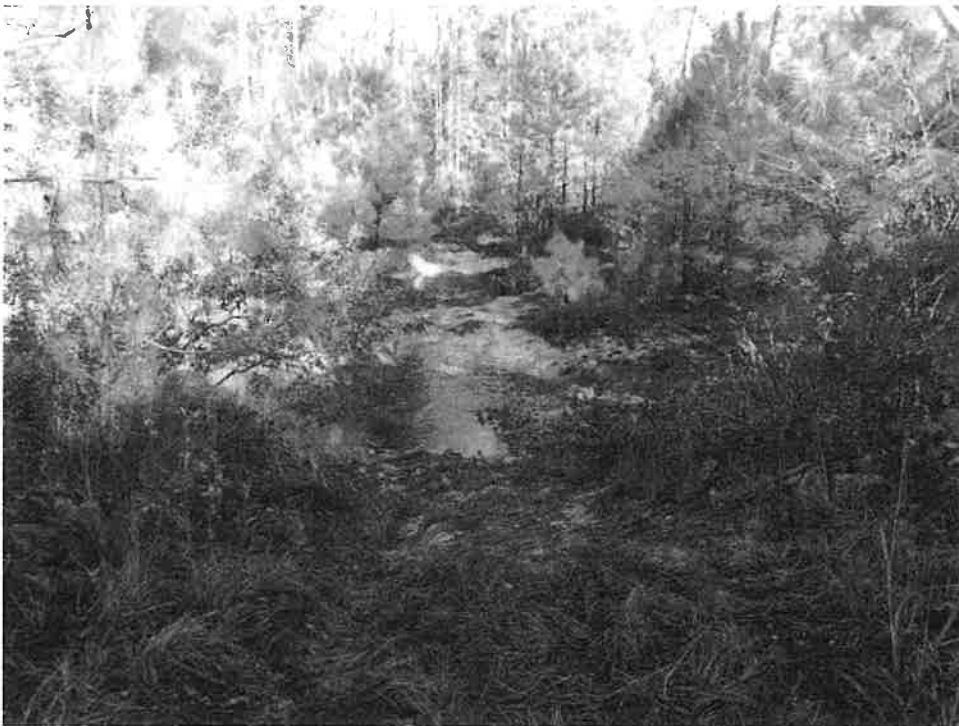
Photo 14: View of an unauthorized crossing on Cherry Creek. This crossing was created by off-road vehicles and ATV's trespassing on the site.

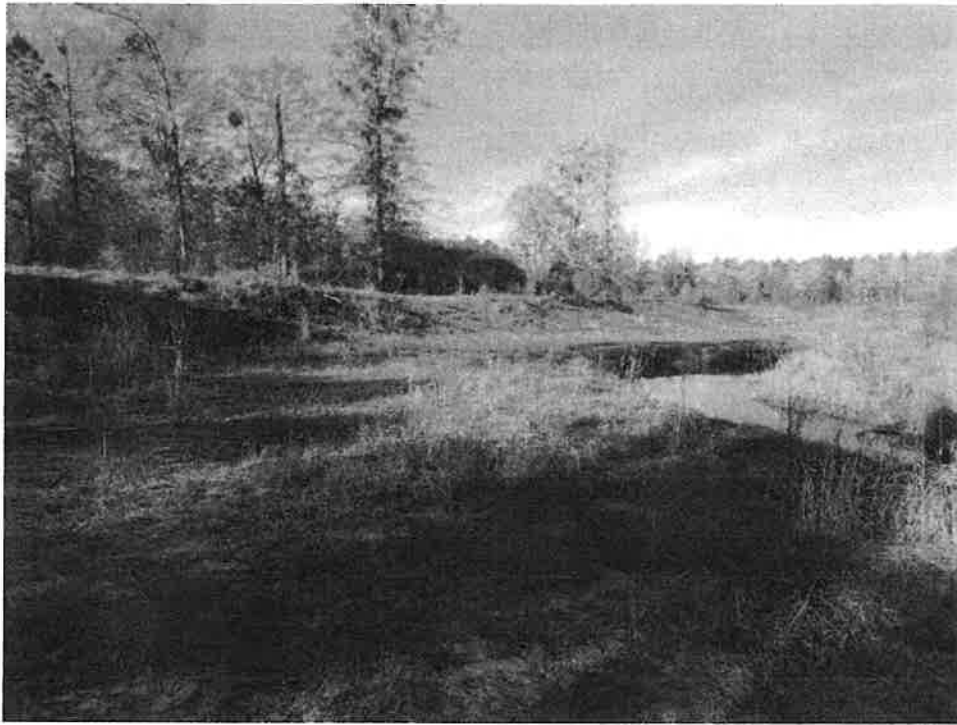
Photo 15: View of the proposed replanting area within the bankfull bench along the south side of Cherry Creek.

The USACE noted that during the site visit a lack of woody riparian vegetation was observed along approximately 400 feet of the left bankfull bench constructed on Cherry Creek. The USACE requested a replanting plan be prepared and implemented by the bank sponsor to address these concerns. The riparian buffer replanting plan will include the following:

- 1) Figure 3 identifies the area of the bank to be replanted.
- 2) In the area identified the bank sponsor will replant with appropriate tree/shrub species along the left bankfull bench (approximately 0.26 acres).
- 3) Trees/shrubs to be planted will include a combination of 1-0 bareroot seedlings or larger (stock to be ≥1' in height) of wax myrtle (*Morella cerifera*), sycamore (*Platanus occidentalis*), red maple (*Acer rubrum*), and bald cypress (*Taxodium distichum*) that are locally sourced and representative of the downstream preservation reach of Cherry Creek.
- 4) Planting composition and density will include the following:

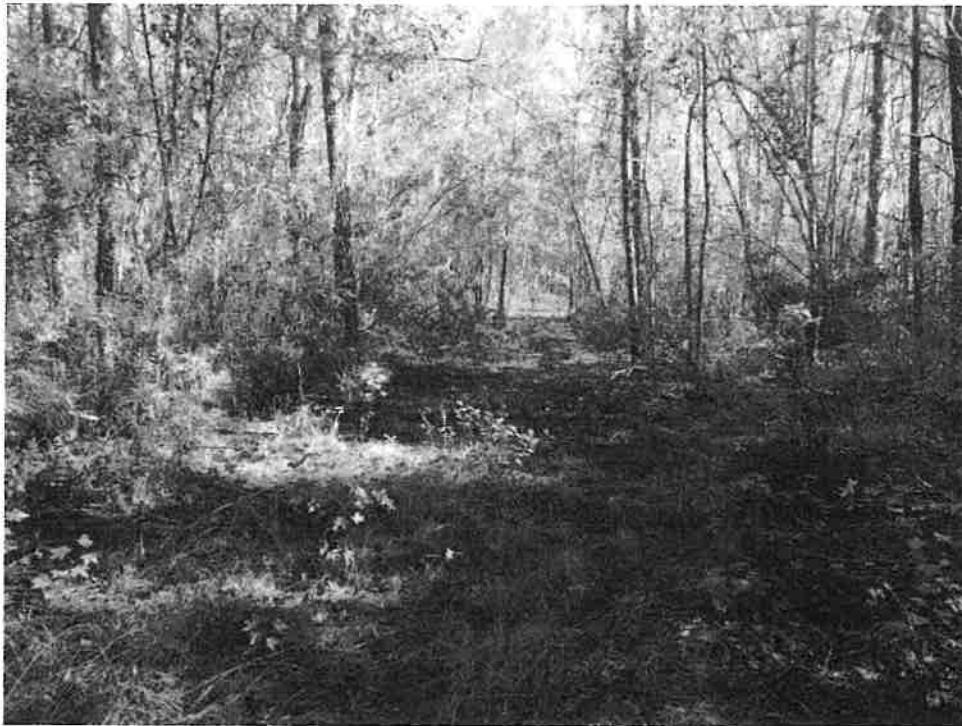
Photo 16: View of the woods road located on the east-central portion of the site. A cable will be installed across this road and additional signage will be placed in the area.

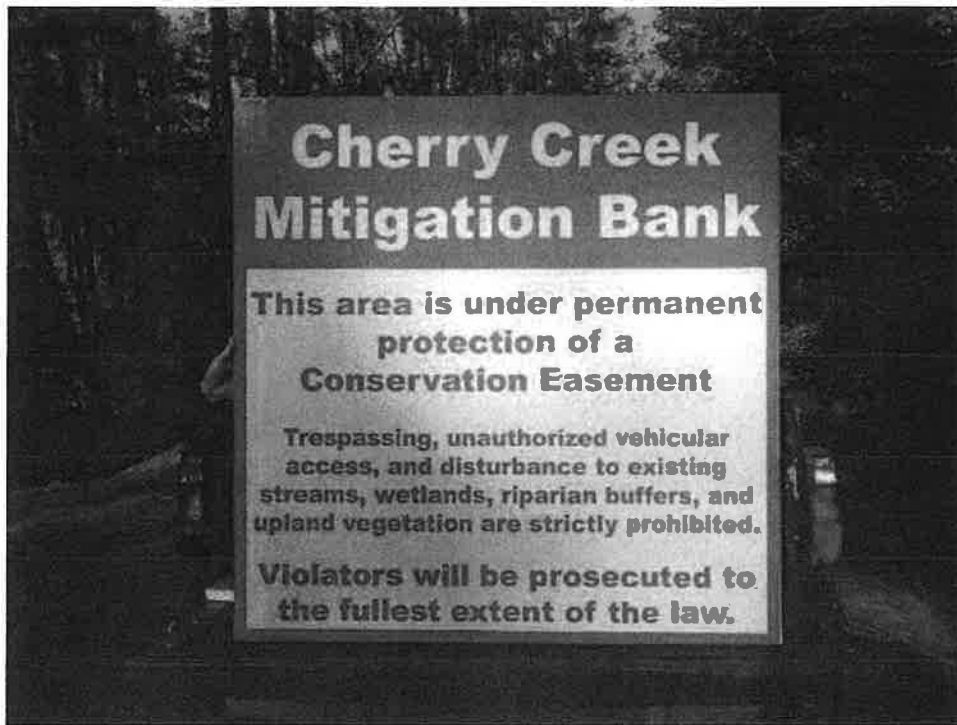
Photo 17: View of the signage that will be installed at each entrance to the site. Additional similar signage will be placed in various locations throughout the site.
