## 4.6 Two Mile Branch

### 4.6.1 Introduction

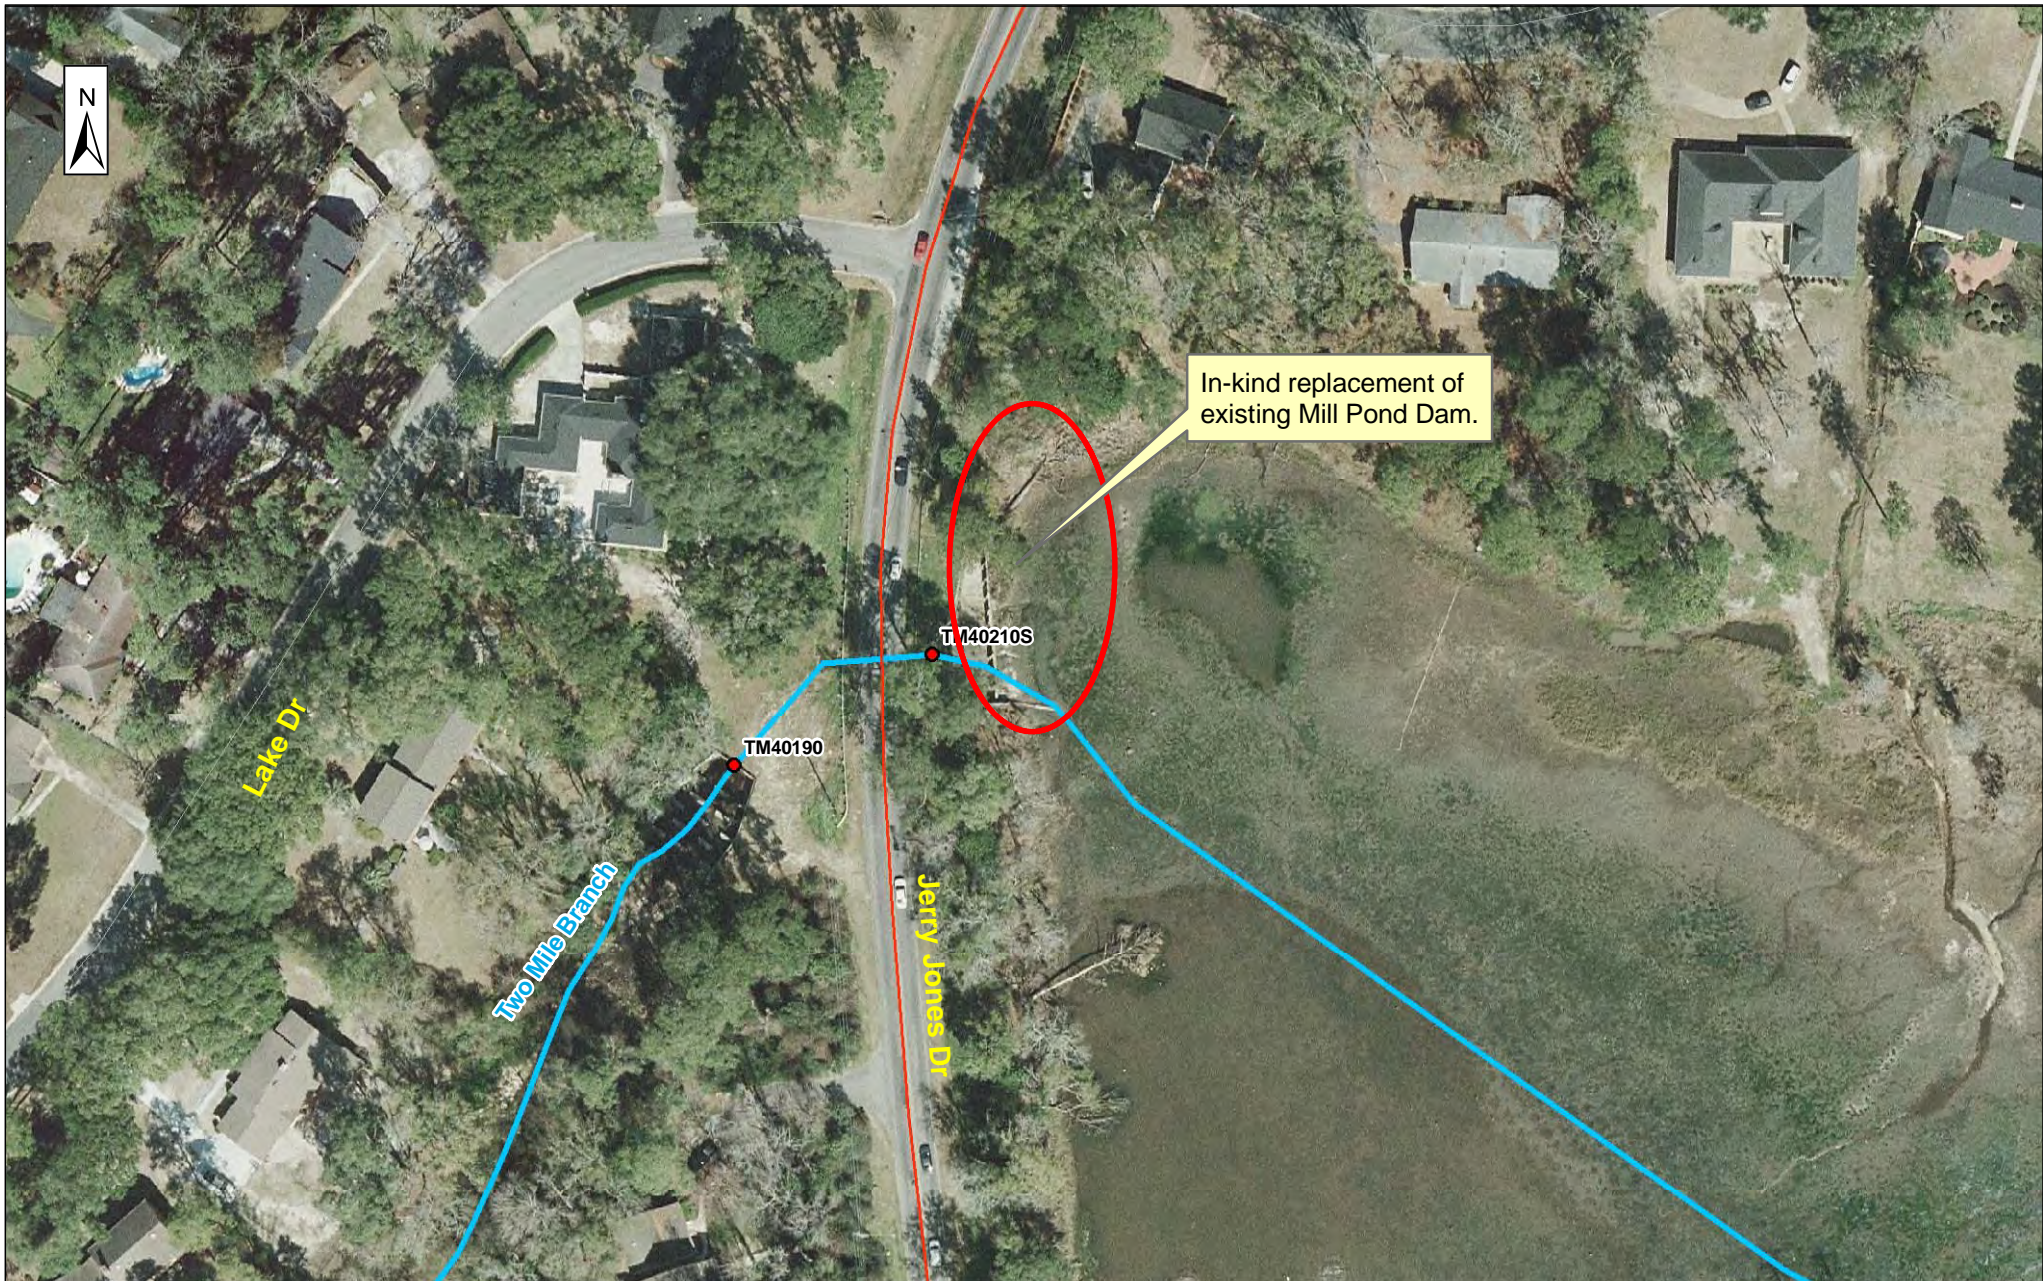
**Figure 4.6.3**  
**City of Valdosta, GA**  
**Two Mile Branch Sub-basin**  
**Alternative TM1**  
**Mill Pond Dam Replacement**

This alternative proposes to demolish the existing dam structure and reconstruct a new in-kind dam structure. The location of the dam is shown on **Figure 4.6.3**. The City has recently improved the Jerry Jones Drive crossing, and no flooding was noted in the current design of the dam and culvert.

The City of Valdosta identified the existing Mill Pond Dam as a public safety hazard due to its age and current structural condition. The City also routinely lowers the water level in Mill Pond in advance of large storm events. In addition to an existing 12-inch outlet pipe, the City also transports pumps to Mill Pond to assist with lowering the water level. This process can take 2-3 days to significantly lower the water level in Mill Pond.

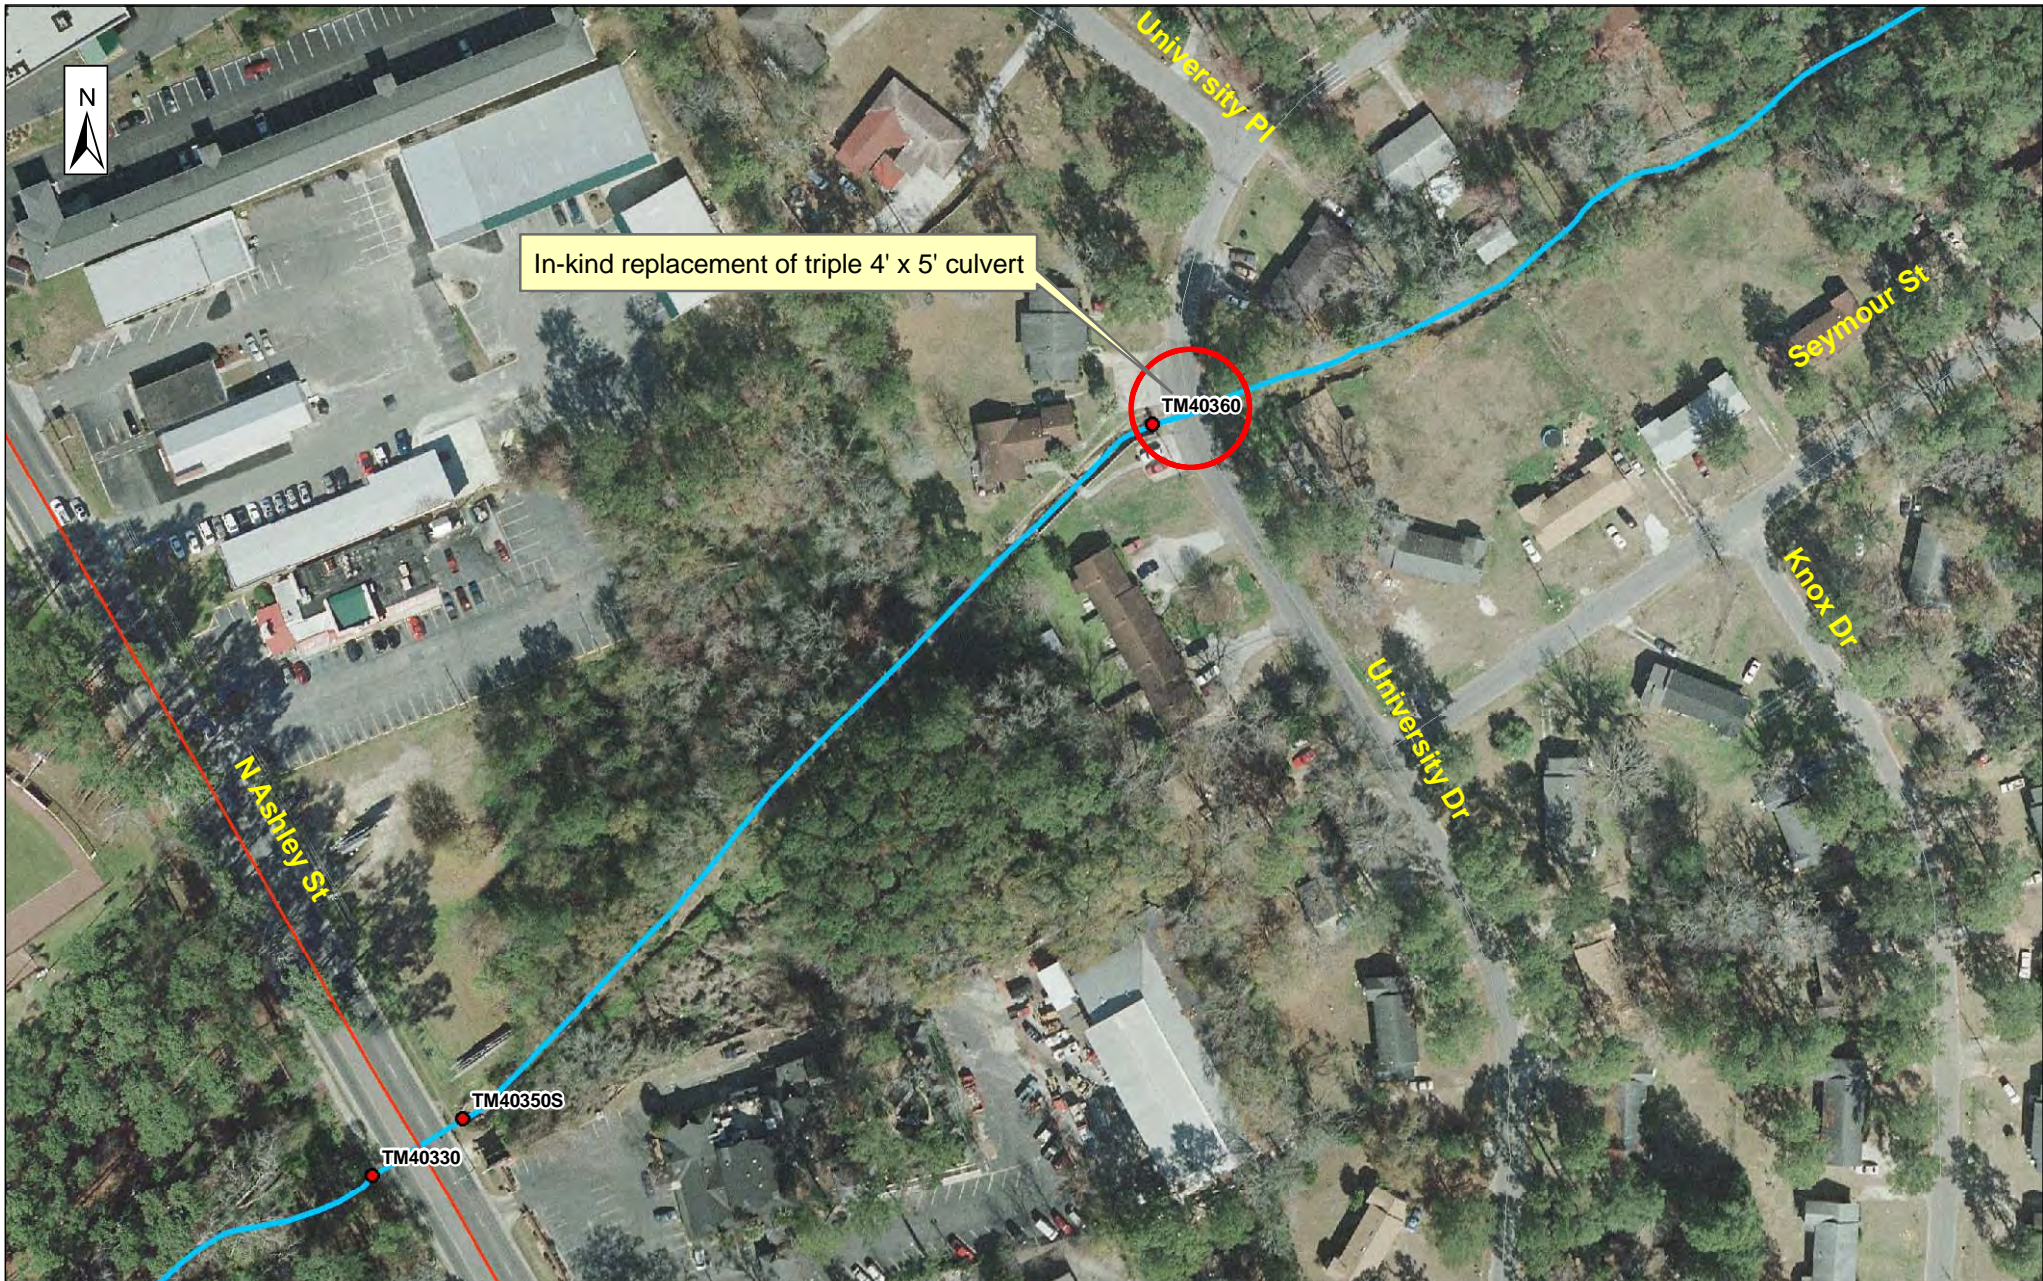
**Figure 4.6.9**  
**City of Valdosta, GA**  
**Two Mile Branch Sub-basin**  
**Alternative TM7**  
**University Drive Culvert Replacement**

No benefits to flood reduction or improvement in water quality occur as part of Alternative TM7. The location of the culvert replacement is shown on **Figure 4.6.9**. **Table 4.6.11** shows the conceptual cost estimates for this alternative.

The existing culvert at University Drive was found to be undersized and is causing University Drive (local road) to not meet the 5-year level of service. Additionally, the City recommended this culvert to be replaced based on its age. During the evaluation of upsizing this culvert, it was found that replacing the existing culvert with a reasonably sized larger culvert would not allow University Drive to meet the 5-year level of service. The water level at University Drive during storm events is controlled by tail-water conditions rather than by the size of the University Drive culvert. Therefore, this alternative recommends an in-kind replacement of the existing 4ft H x 5 ft W triple box culvert, based on the recommendation by the City.

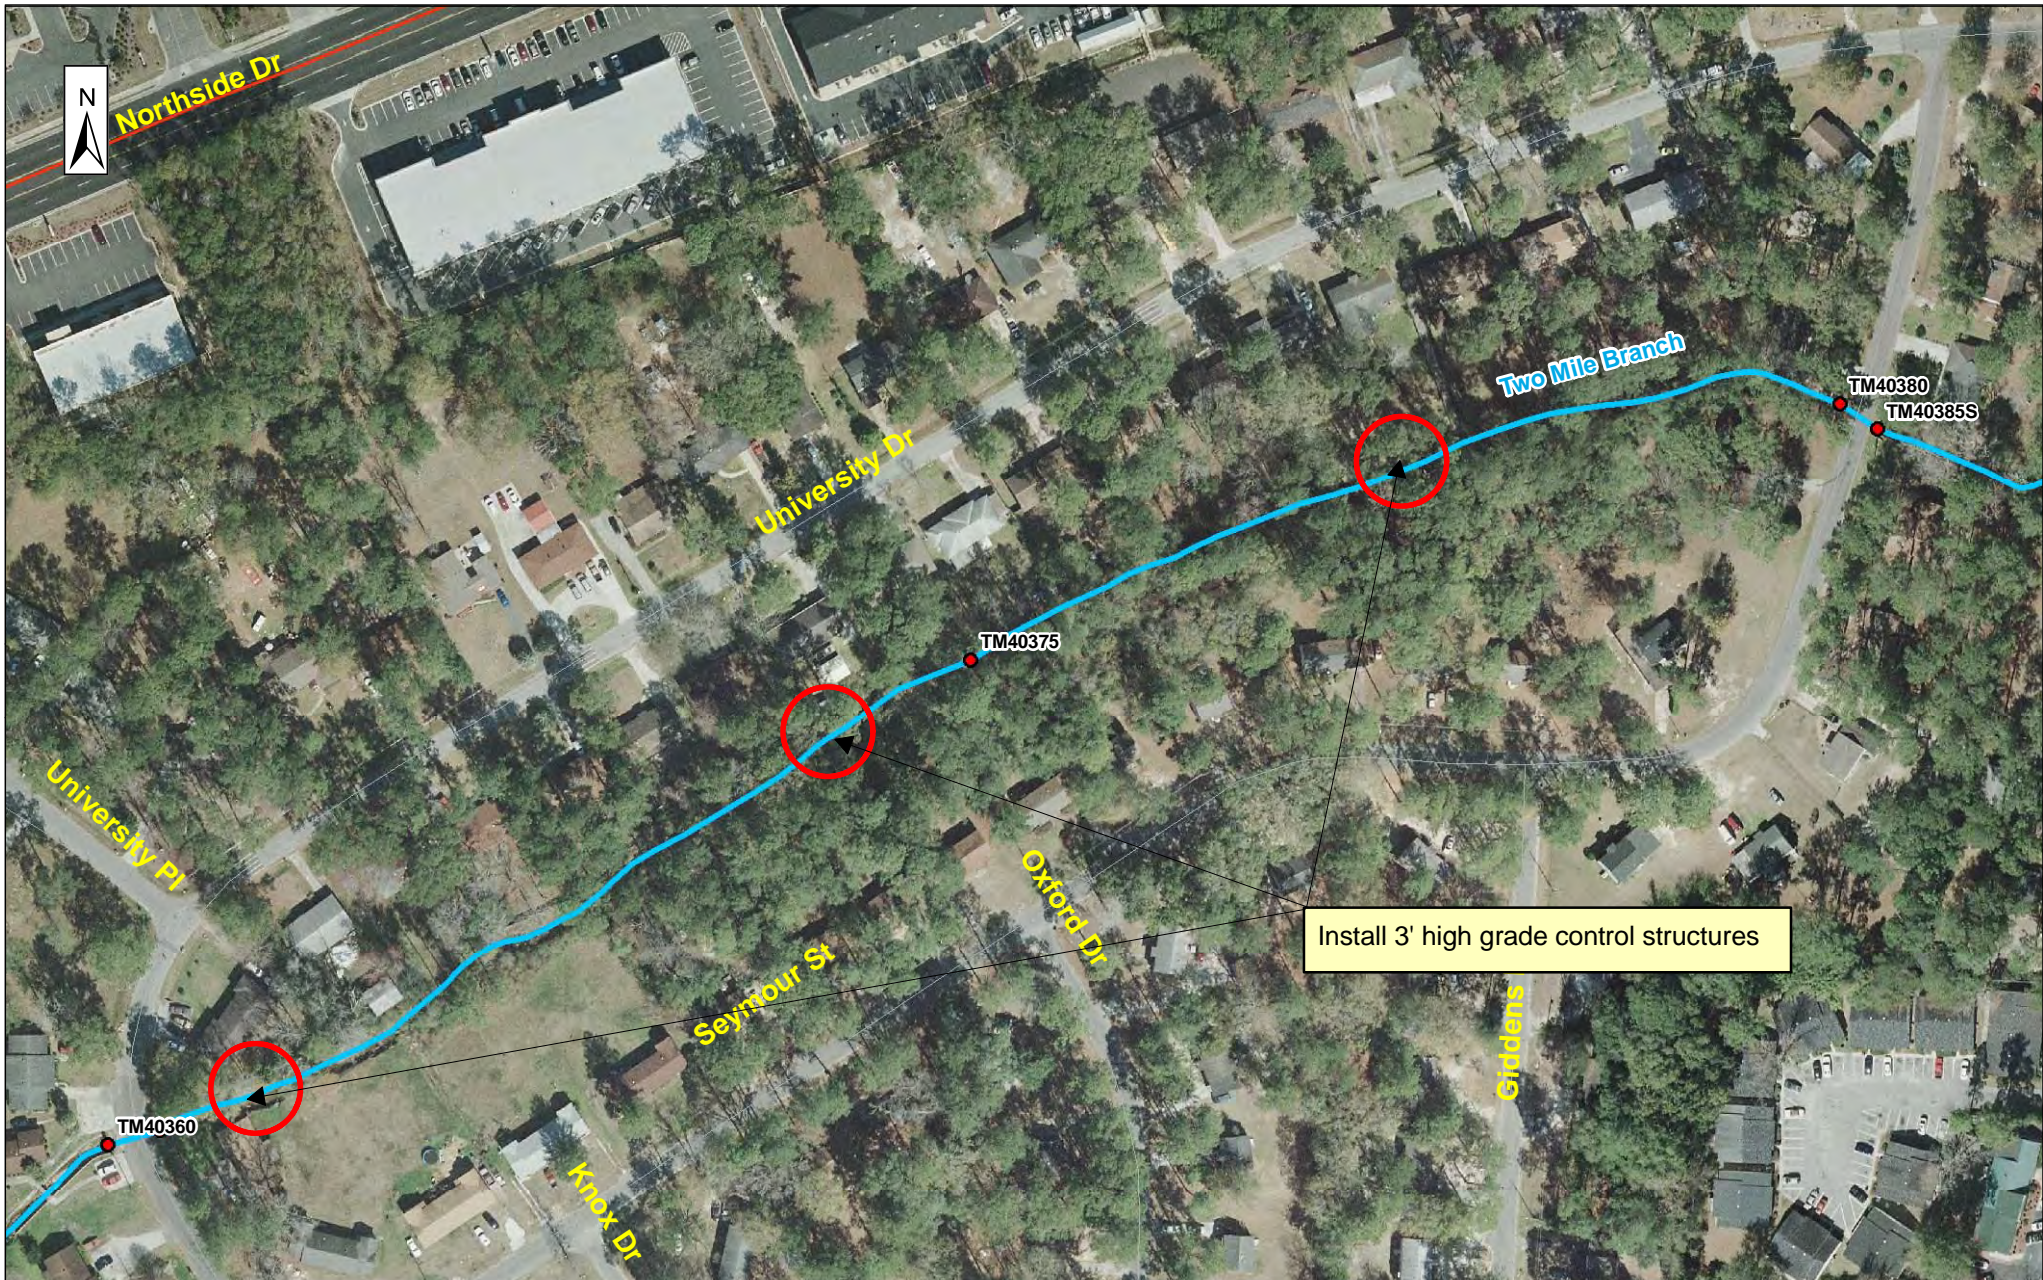
The approximate location of the grade control structures is shown on **Figure 4.6.10**. **Table 4.6.12** shows the conceptual cost estimates for this alternative. CDM recommends detailed geomorphologic assessment is carried out before commencing any design or construction for a grade control project.

In its existing condition, velocities reaching almost 7 ft/sec during the 1.2-inch storm are observed in the stormwater model. After completion of Alternative TM5, peak stream velocities are reduced to less than 4 ft/sec. No stream velocities are observed above the erosive threshold, which for the soils predominant in Two Mile Branch is 5 ft/sec.
