## 4.7 Three Mile Branch

### 4.7.1 Introduction

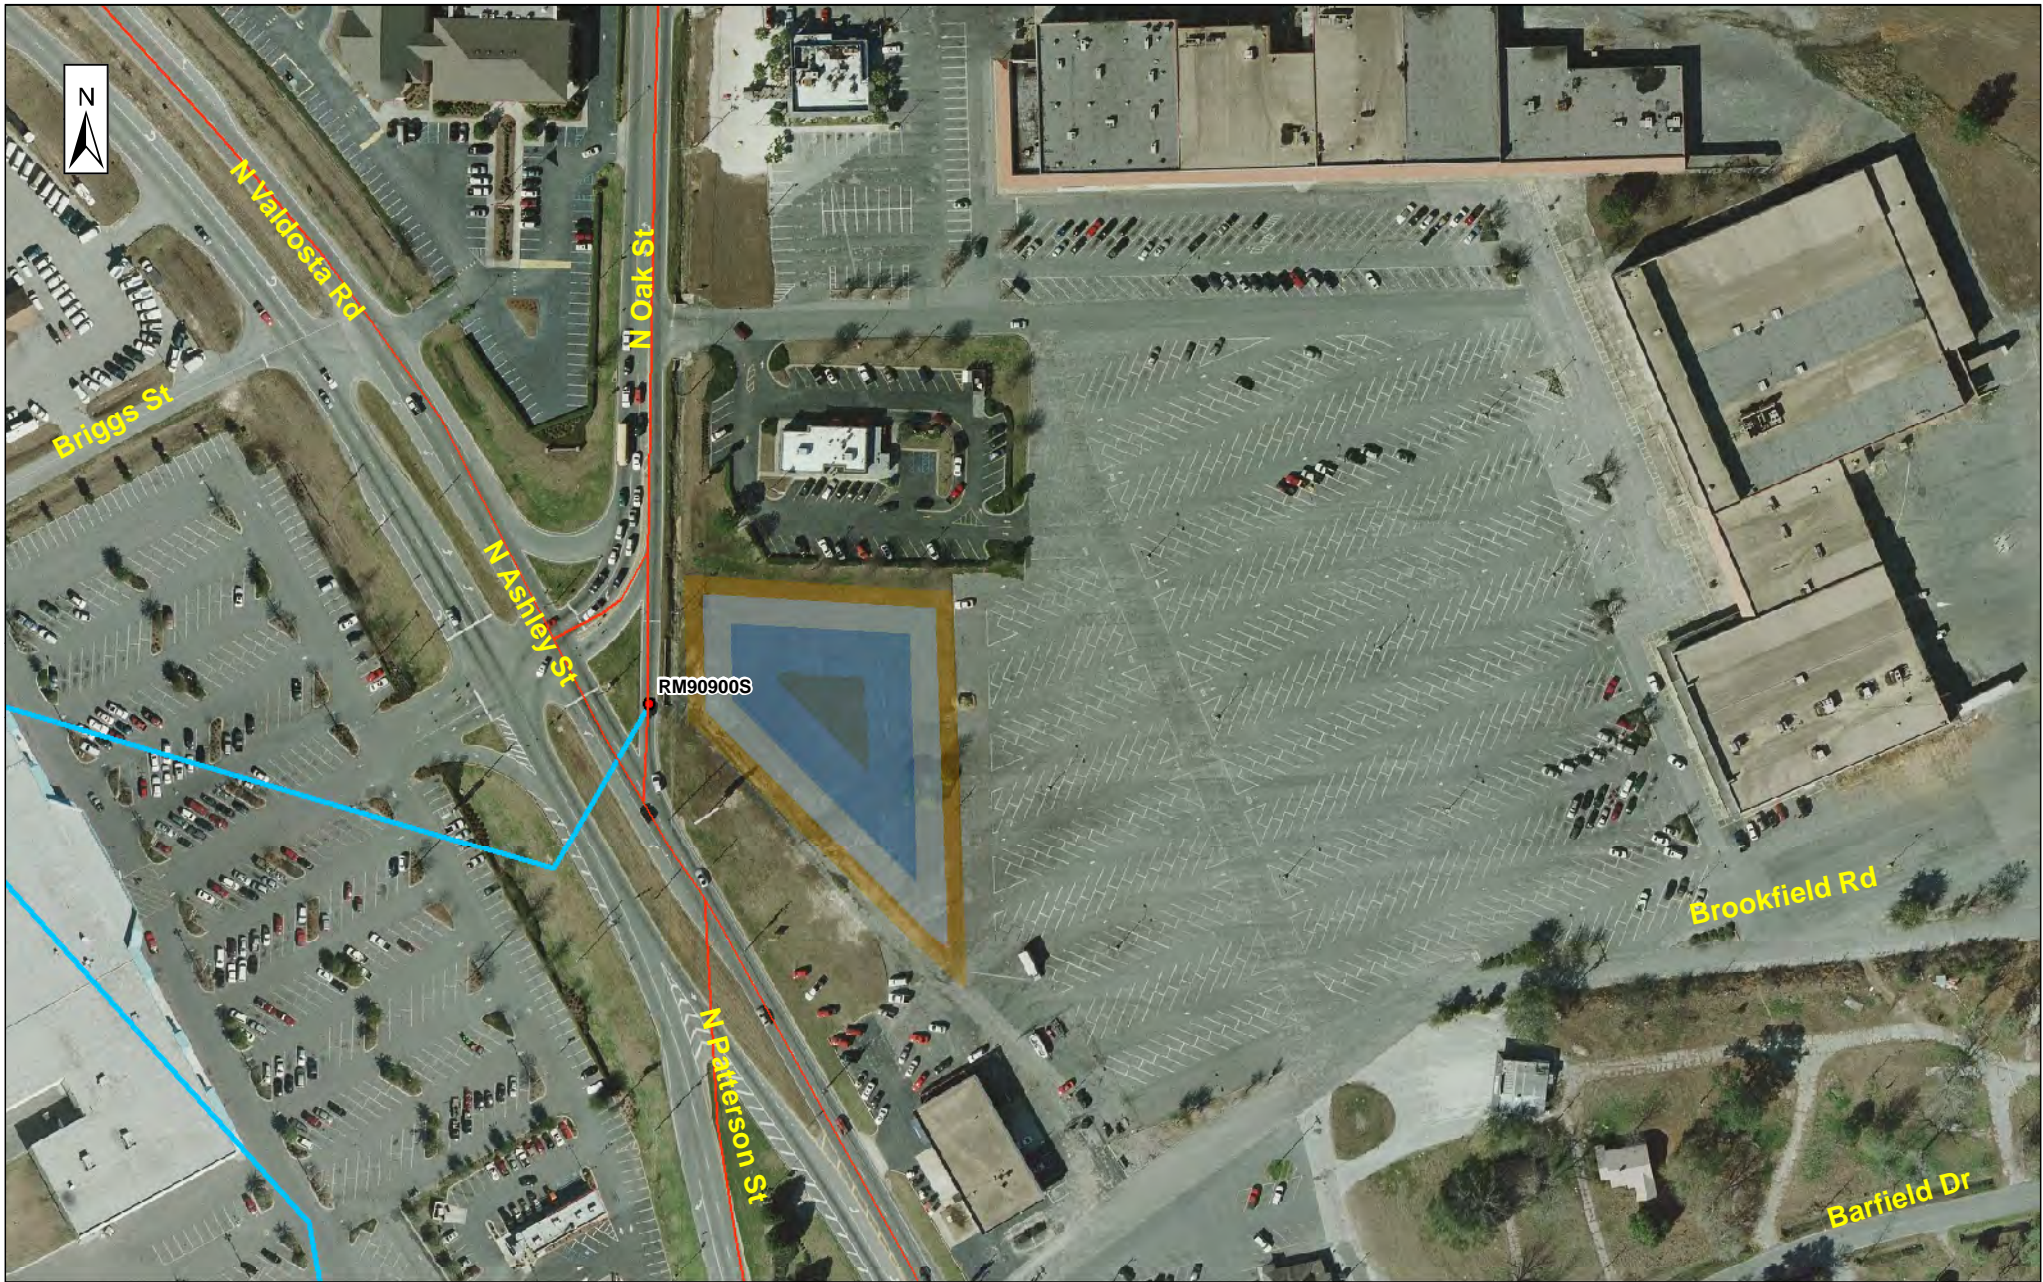
**Figure 4.7.4**  
**City of Valdosta, GA**  
**Three Mile Branch Sub-Basin**  
**Alternative RM2**

**Regional Stormwater Facility at Five Points Location**

The City has acquired the majority of the Five Points complex. There are redevelopment plans for this location. CDM proposes to include implementation of a RSF as part of the redevelopment plans of this location. A 1.3-acre detention facility has been proposed at the location shown on **Figure 4.7.4**. This facility would provide stormwater runoff treatment for the 15 acres of impervious area of the Five Points complex. The proposed RSF has a Permanent Pool Volume of 3.0 ac-ft and a Residence Time of 16 days. The location and size of this RSF is subject to change as the City moves ahead with the redevelopment plans for this location in the future. **Table 4.7.6** shows the conceptual cost estimates for this alternative.
