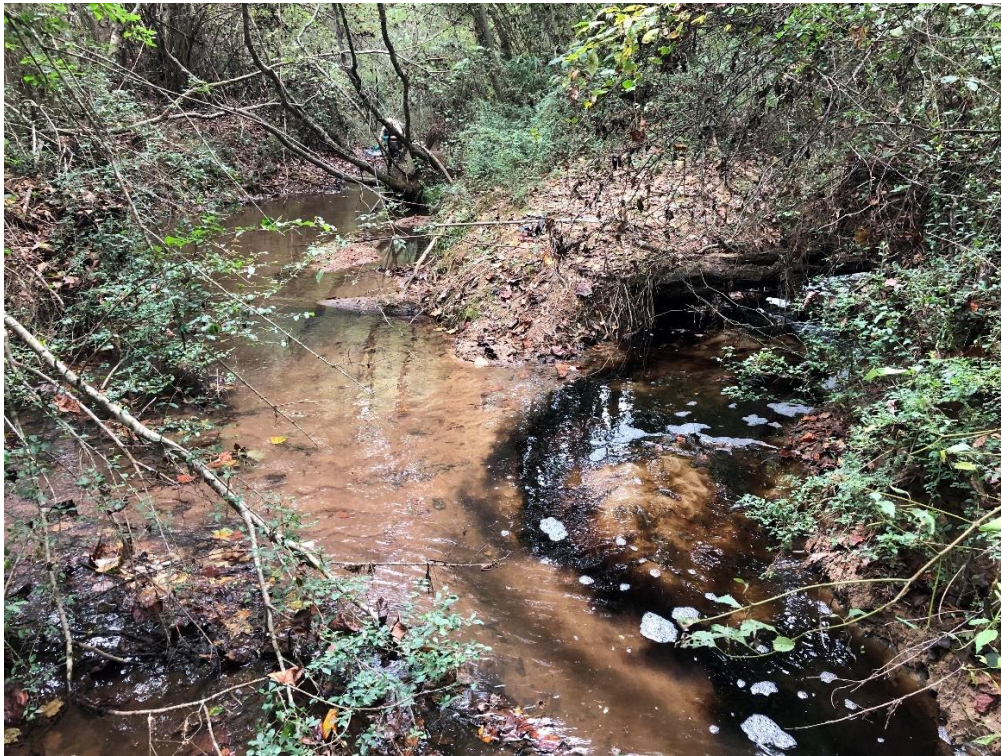
Photo 7. Confluence of Indian Creek (left) and the Unnamed Tributary of Indian Creek (right) that drained the Franklin Biomass Generating Facility’s retention ponds. Photograph taken by Anthony Rabern on October 6, 2019.

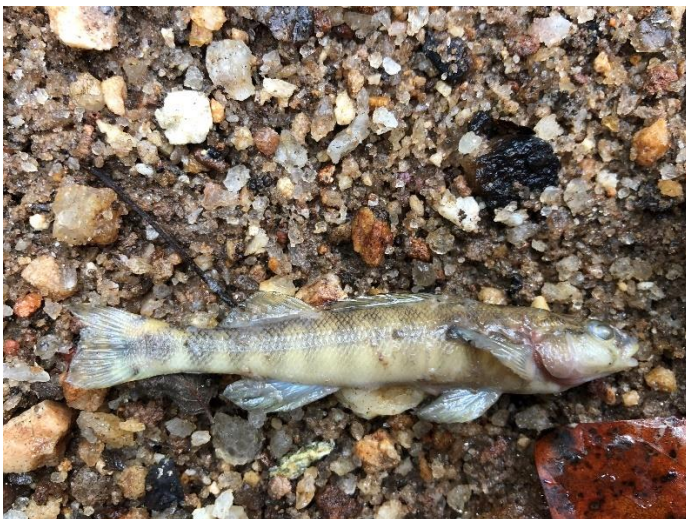
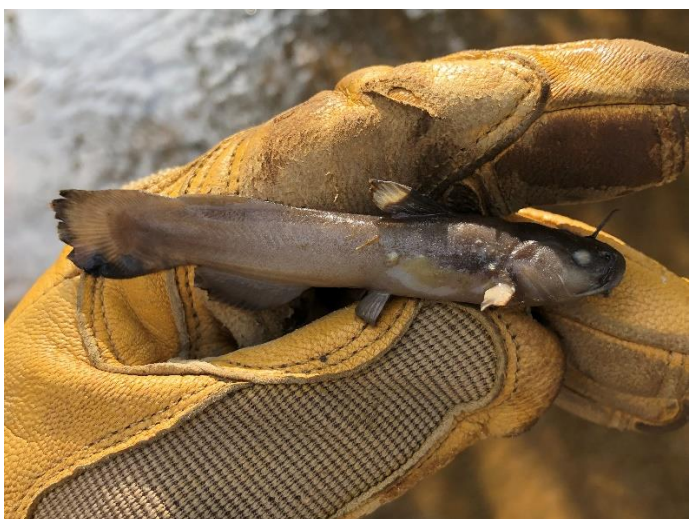
Photos 8&9. Fish mortalities collected by Anthony Rabern in Indian Creek downstream of the Unnamed Tributary of Indian Creek on October 6, 2019. Photographs were taken by Anthony Rabern.
