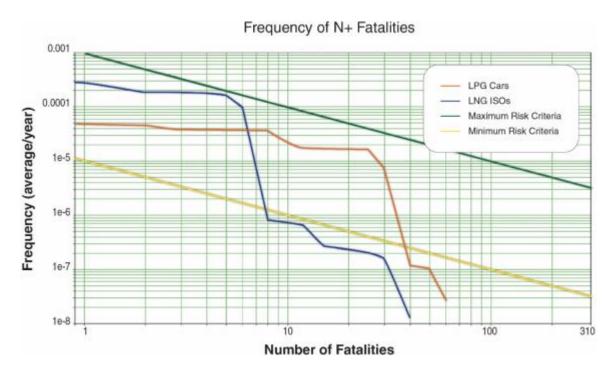
Figure 58. FN curve comparison for LNG ISOs and LPG train movements in the Hialeah Yard. Note that Lift On/Lift Off was not considered for LPG; the risk corresponds to only train movements in the yard.
