### Riverine/Stream Erosion

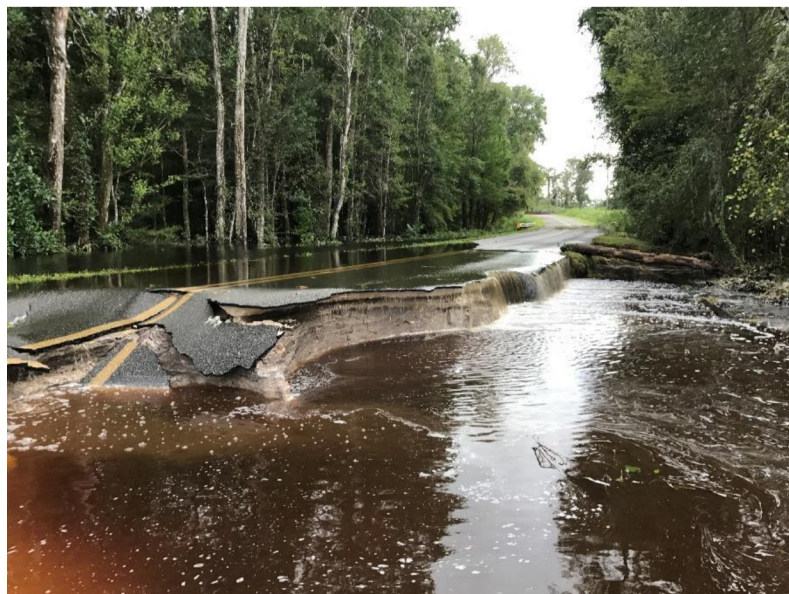
Roadway damage cause by erosion due to flooding during Hurricane Irma, 2017 – Bradford County File Photo

Defined by the Federal Emergency Management Agency as the “collapse, undermining or subsidence of land along the shore of a lake or other body of water”, erosion can contribute to the hazards face by many structures built along waterways. Erosion can cause loss to both land or development, with the worst case scenario being structural collapse. Riverine erosion can, and in the past has, contributed to damage of paved roads, along with other infrastructure.

The loss of soils due to riverine erosion under paved roads, bridge abutments and approaches, bridge pilings and other structural pilings, can cause structural failures that endanger public safety. Washouts of boat ramps can restrict access for emergency personnel. Riverine
